# Port Talbot

Light Pollution Study

15 July 2024

## 1. Executive Summary

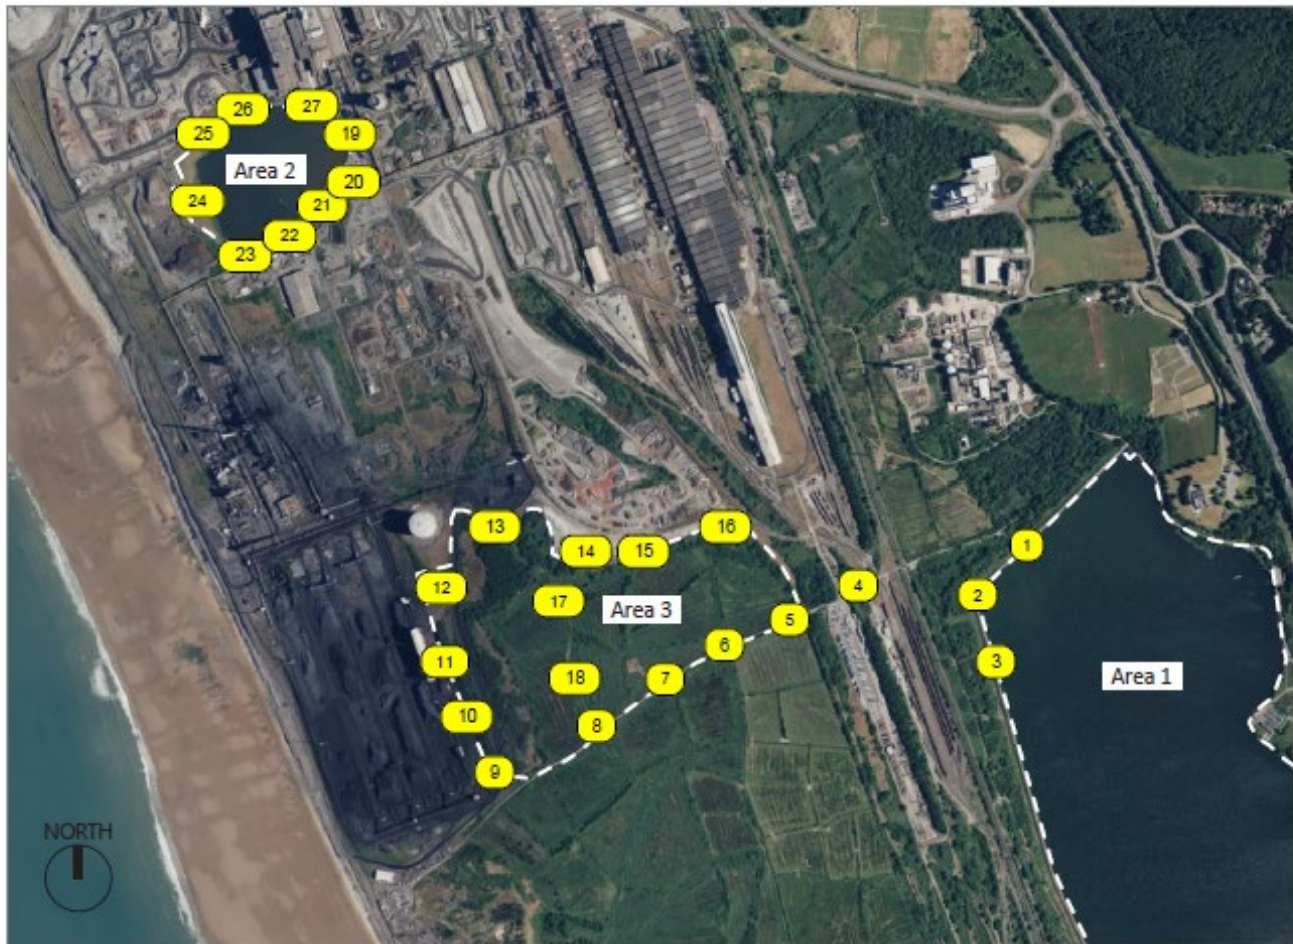
Figure 1: Sensitive Areas and Reading Locations

Three areas were identified due to sensitive wild- life (marked in blue in fig. 1), particularly bats:

Areas 1: Eglwys Nunydd Reservoir.

Area 2: Internal reservoir.

Area 3: Green area with fields, trees and bushes, and featuring an access road (Healcaeir-Bont) and a path (Lower Mother).

A number of reading locations were selected (Points 1 to 27 in fig. 1), chiefly along the perimeter of the sensitive Areas, but also within Area 3 along Healcaeir-Bont Road (Points 4 to 8) and Lower Mother path (Points 17 and 18).

The results for Area 1 show an average value is 0.21 lx, with a standard deviation of 0.1 lx and a maximum of 0.45 lx.

Area 2 showed the most relevant recordings in the survey. The average illuminance was 4.8 lx, with a standard deviation of 5.2 lux and a maxi- mum of 18.1 lx. The highest values were record- ed along the eastern boundary (Points 19 to 22, and 27) looking primarily east and away from the Area.

Results along the access path in Area 3 (points 4 to 8) showed an average illuminance of 0.31 lux, with a standard deviation of 0.24 lux and a maximum of 1.07 lx. It should be noted that measurements Points 17 and 18 were not possible due the excessive vegetation.

The perimeter of Area 3 showed low values in general, apart from Point 11. This Point received a maximum of 10.3 lx from the southwest, whilst for the rest of points (9-10

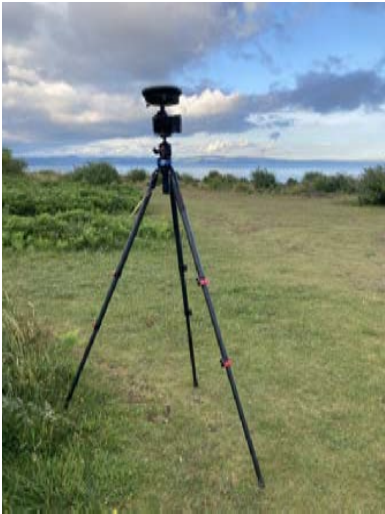
Manfrotto tripod with  
GS16 antennae

The position of each camera location was surveyed using a Leica GS16 GNSS Smart Rover Antennae which can capture Eastings and Northings and height (in metres Above Ordnance Datum) along with a CS20 data controller and recorder to display the antennae point location down to cm accuracy.

A sturdy Manfrotto ..... tripod was used to mount the camera. The Leica GS16 Smart Rover antennae was first mounted to the camera for the location to be recorded. The tripod was then positioned according to pre-provided GPS co-ordinates as closely as possible. Once in position, the antennae was removed, and the camera level was fine tuned using a three-way levelling base and inclinometer. The camera was set with the centre of the lens at 1.60m above ground level. Camera settings were set to Manual mode to allow full control over aperture and shutter speed. ISO was fixed at ISO 100, and an aperture of f/8 was used while sunlight was still available. The aperture was gradually opened in conjunction with a slower shutter speed as light levels dropped. Care was taken not to reduce the shutter speed to far, due to windy conditions and billowing steam stacks on site, which would have created blurry and confusing shapes within the images.

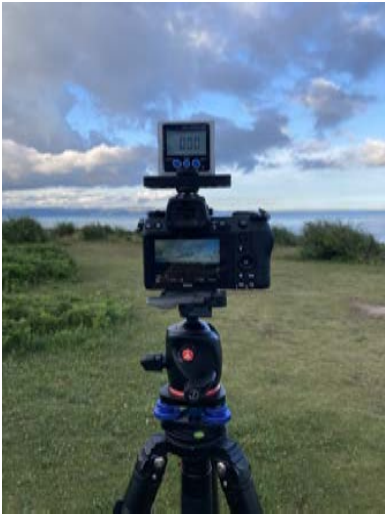
Three-way levelling base  
and inclinometer

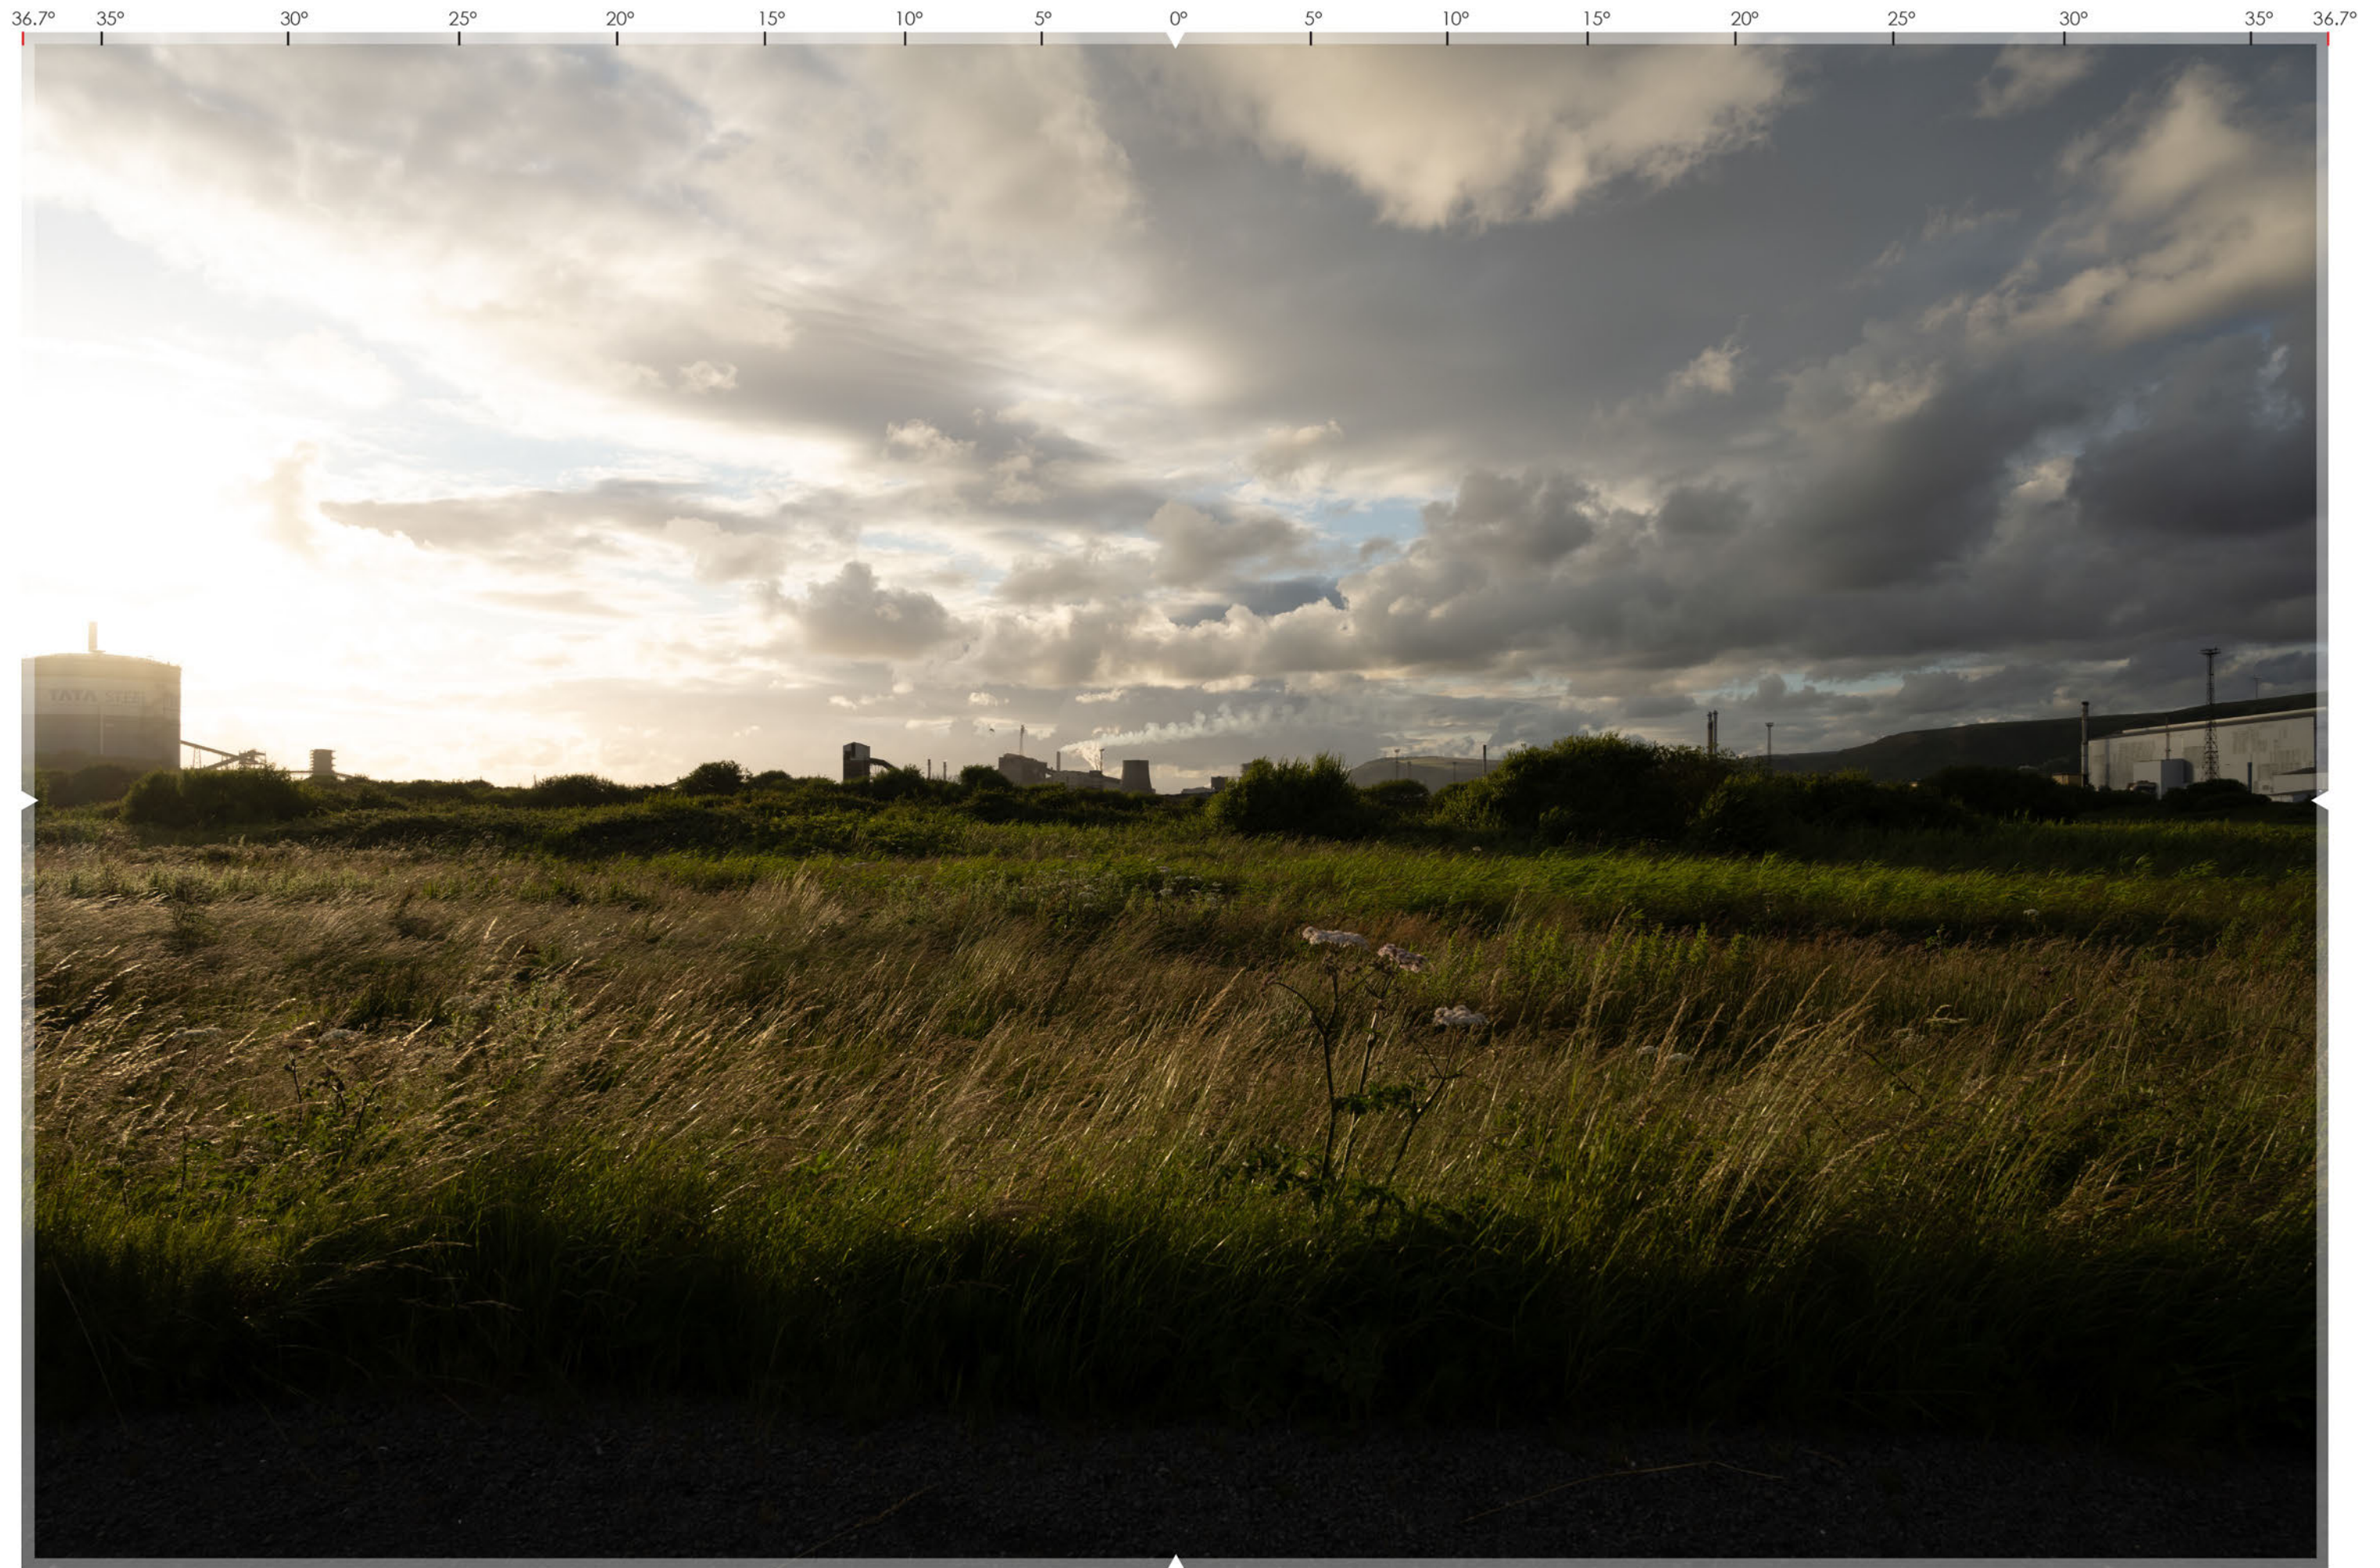
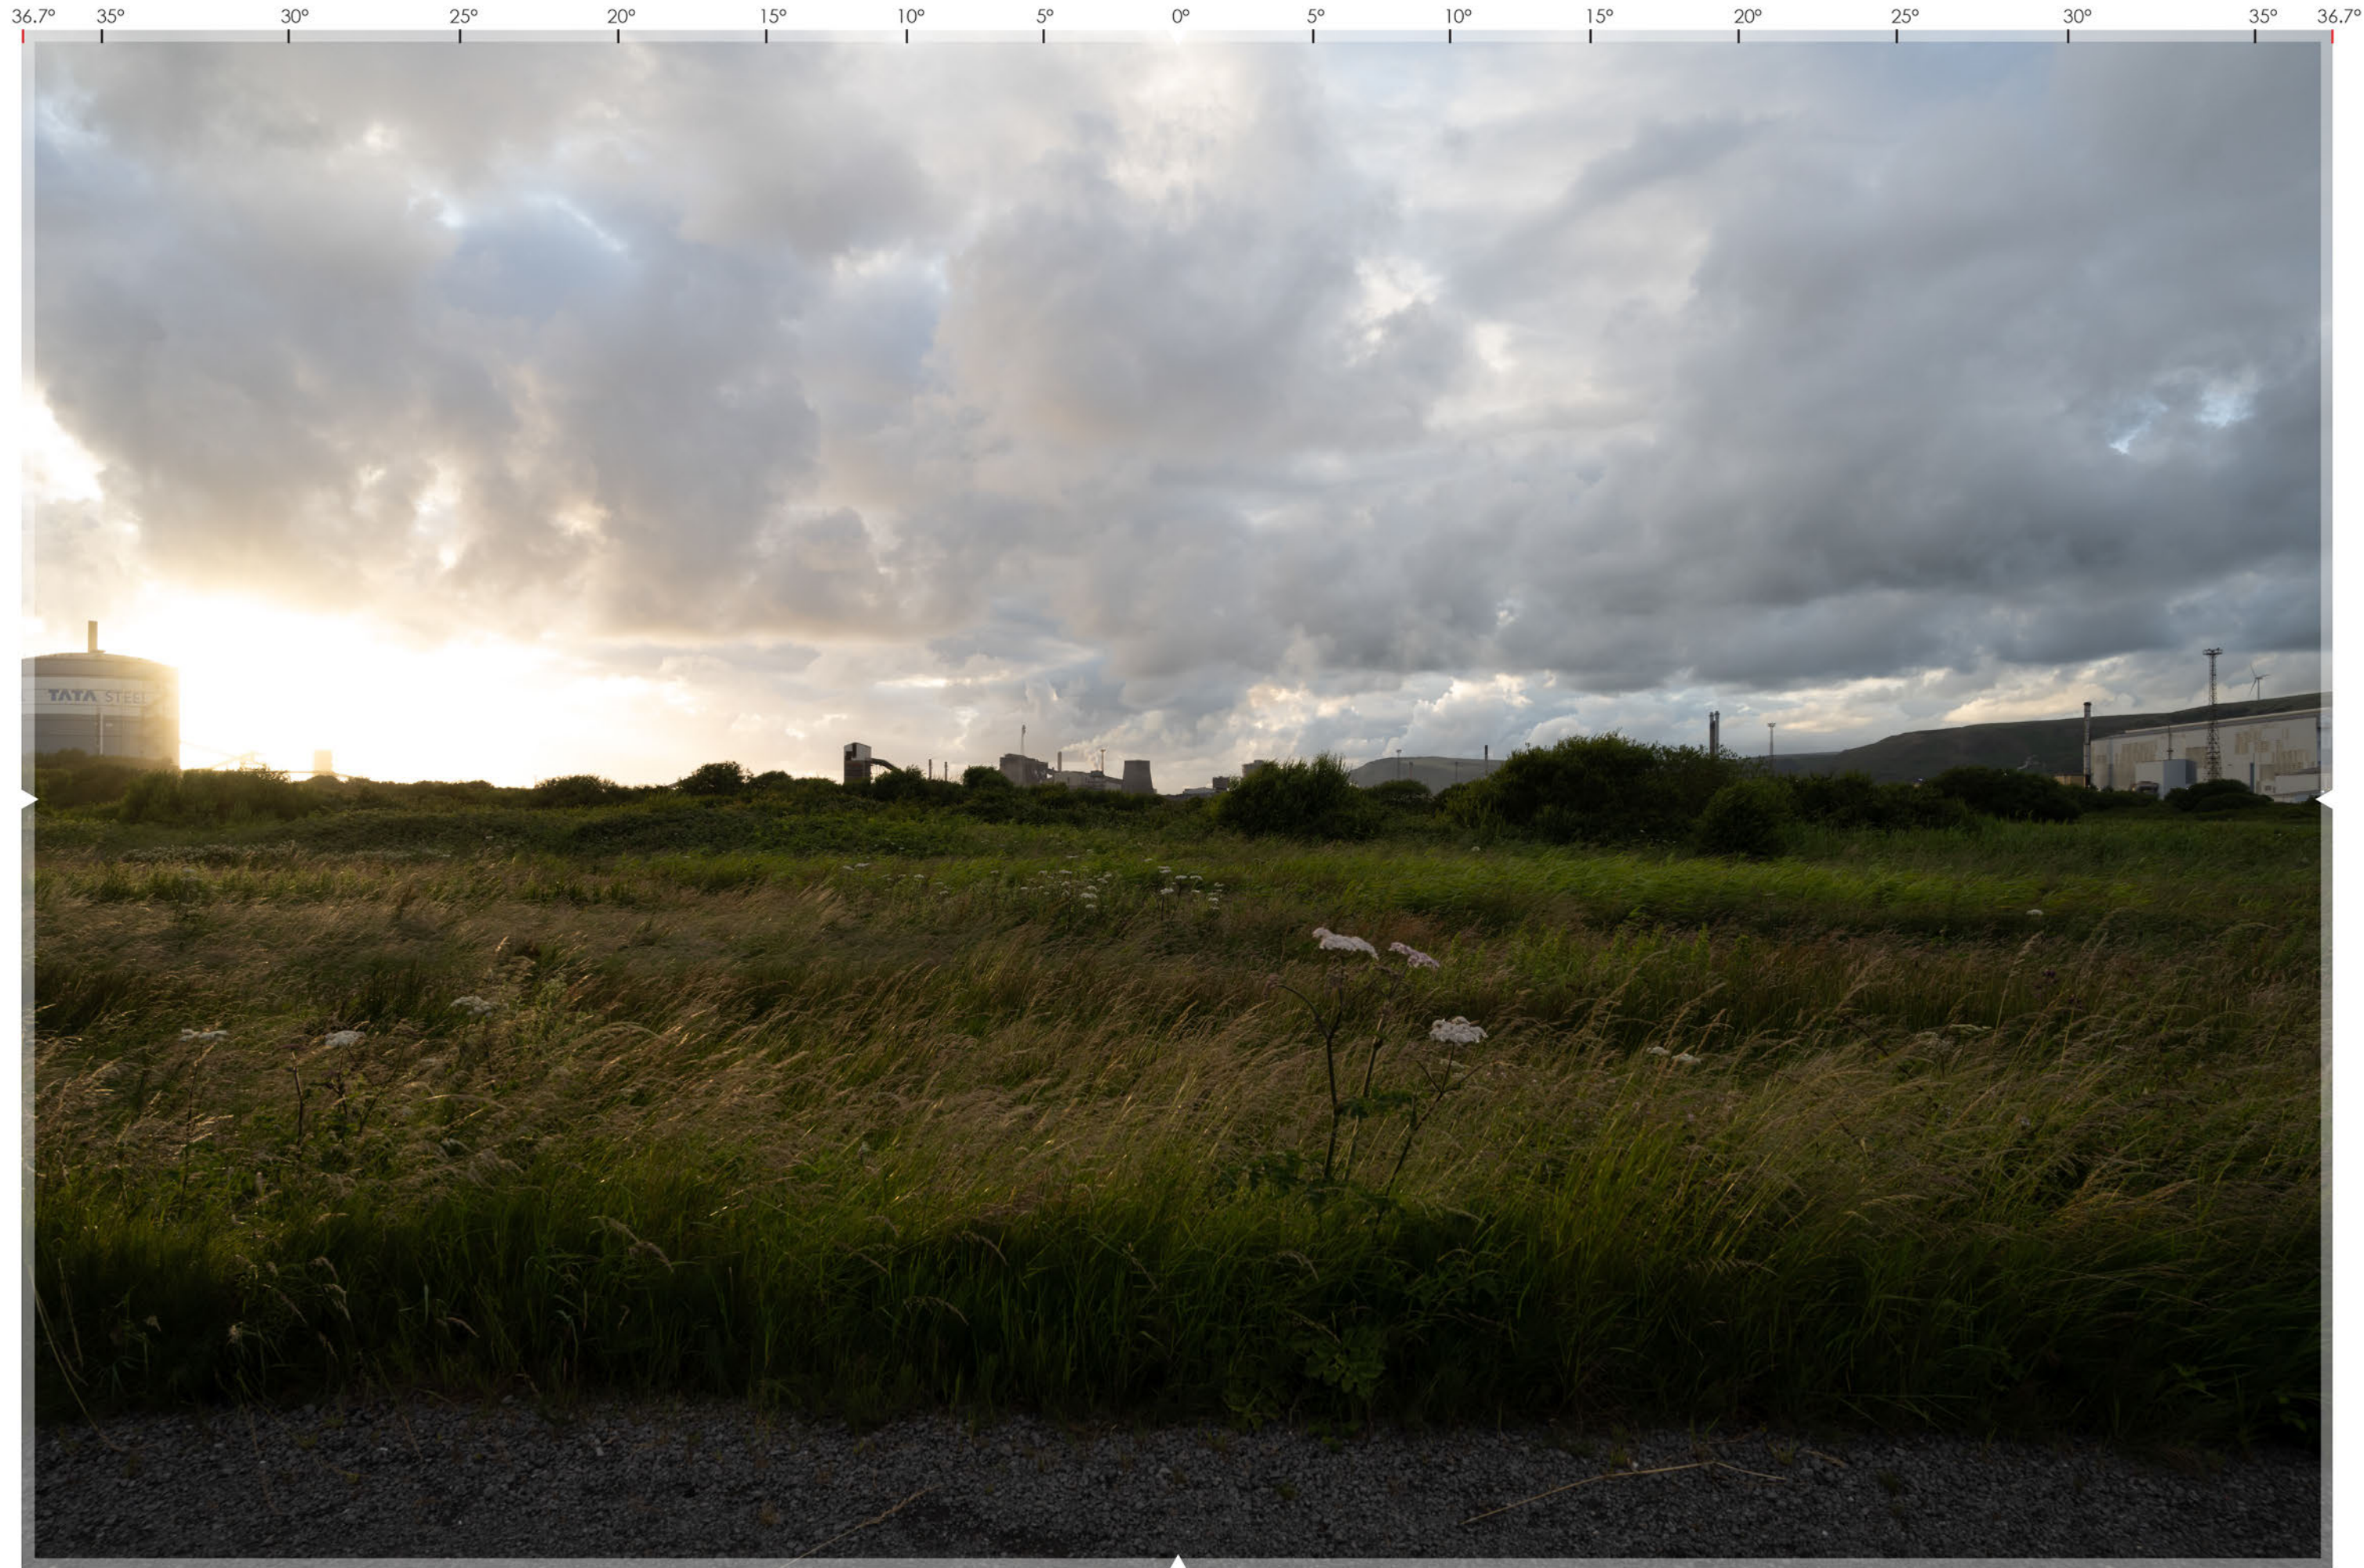
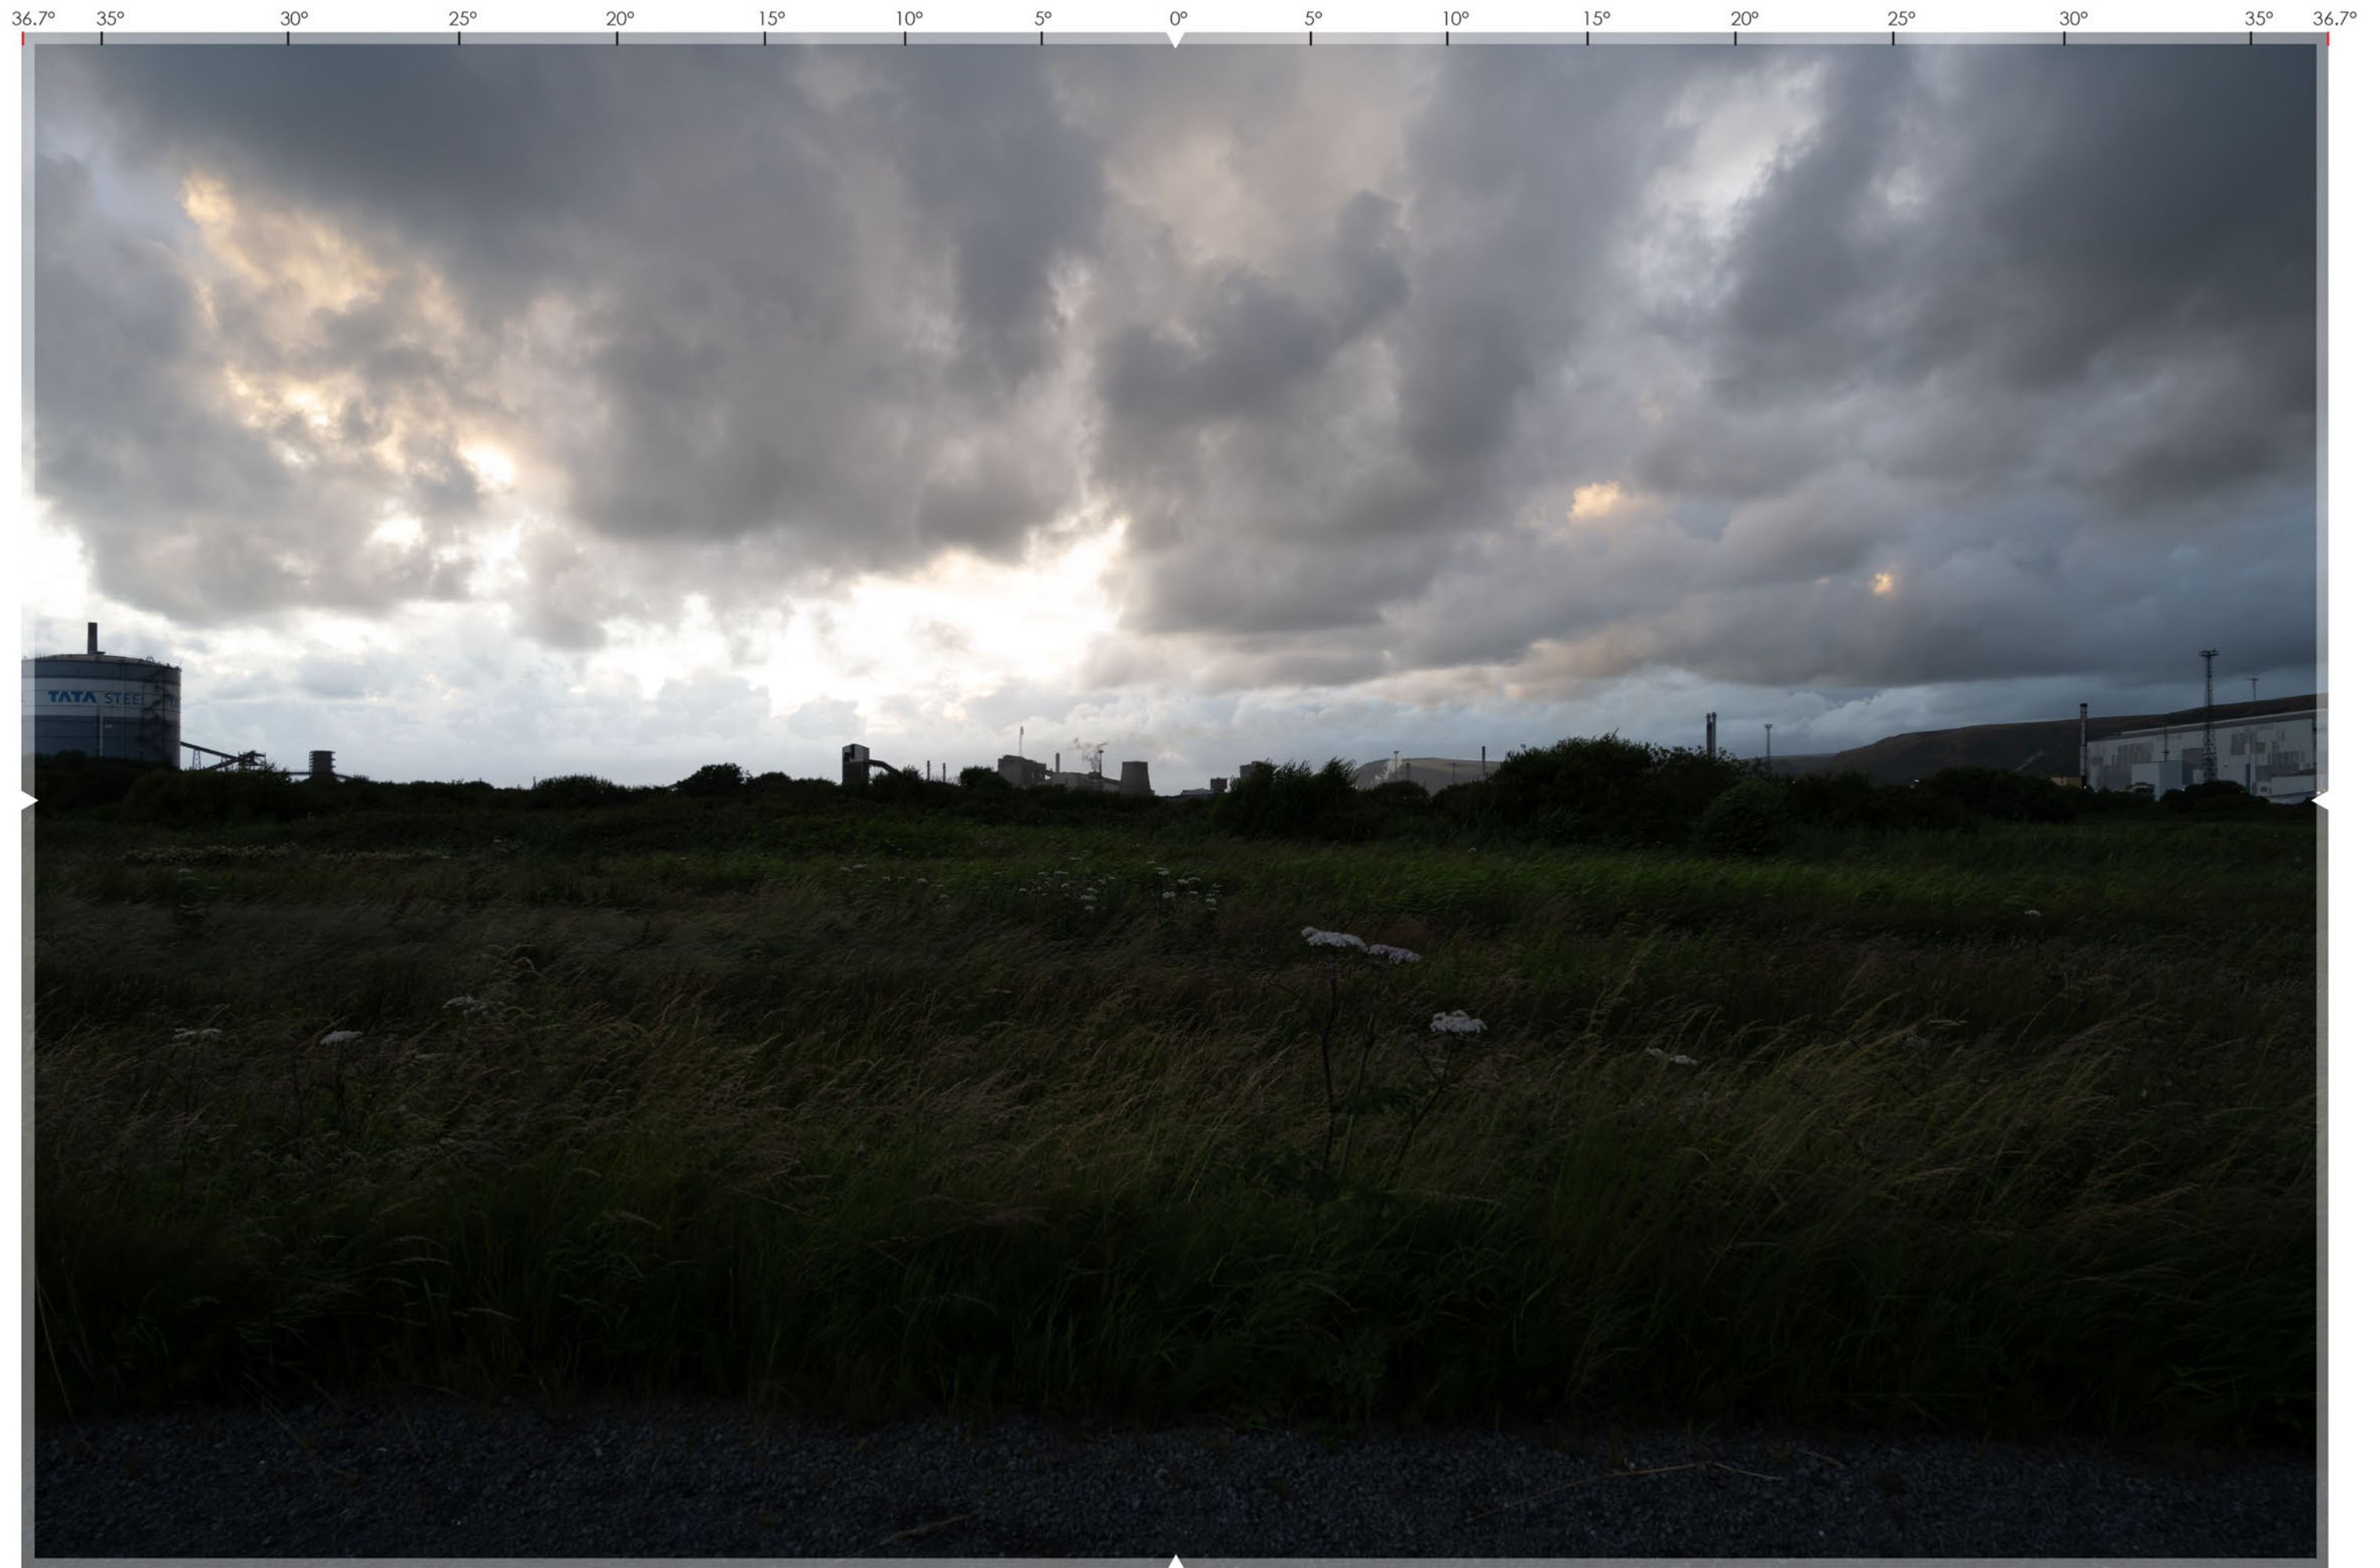
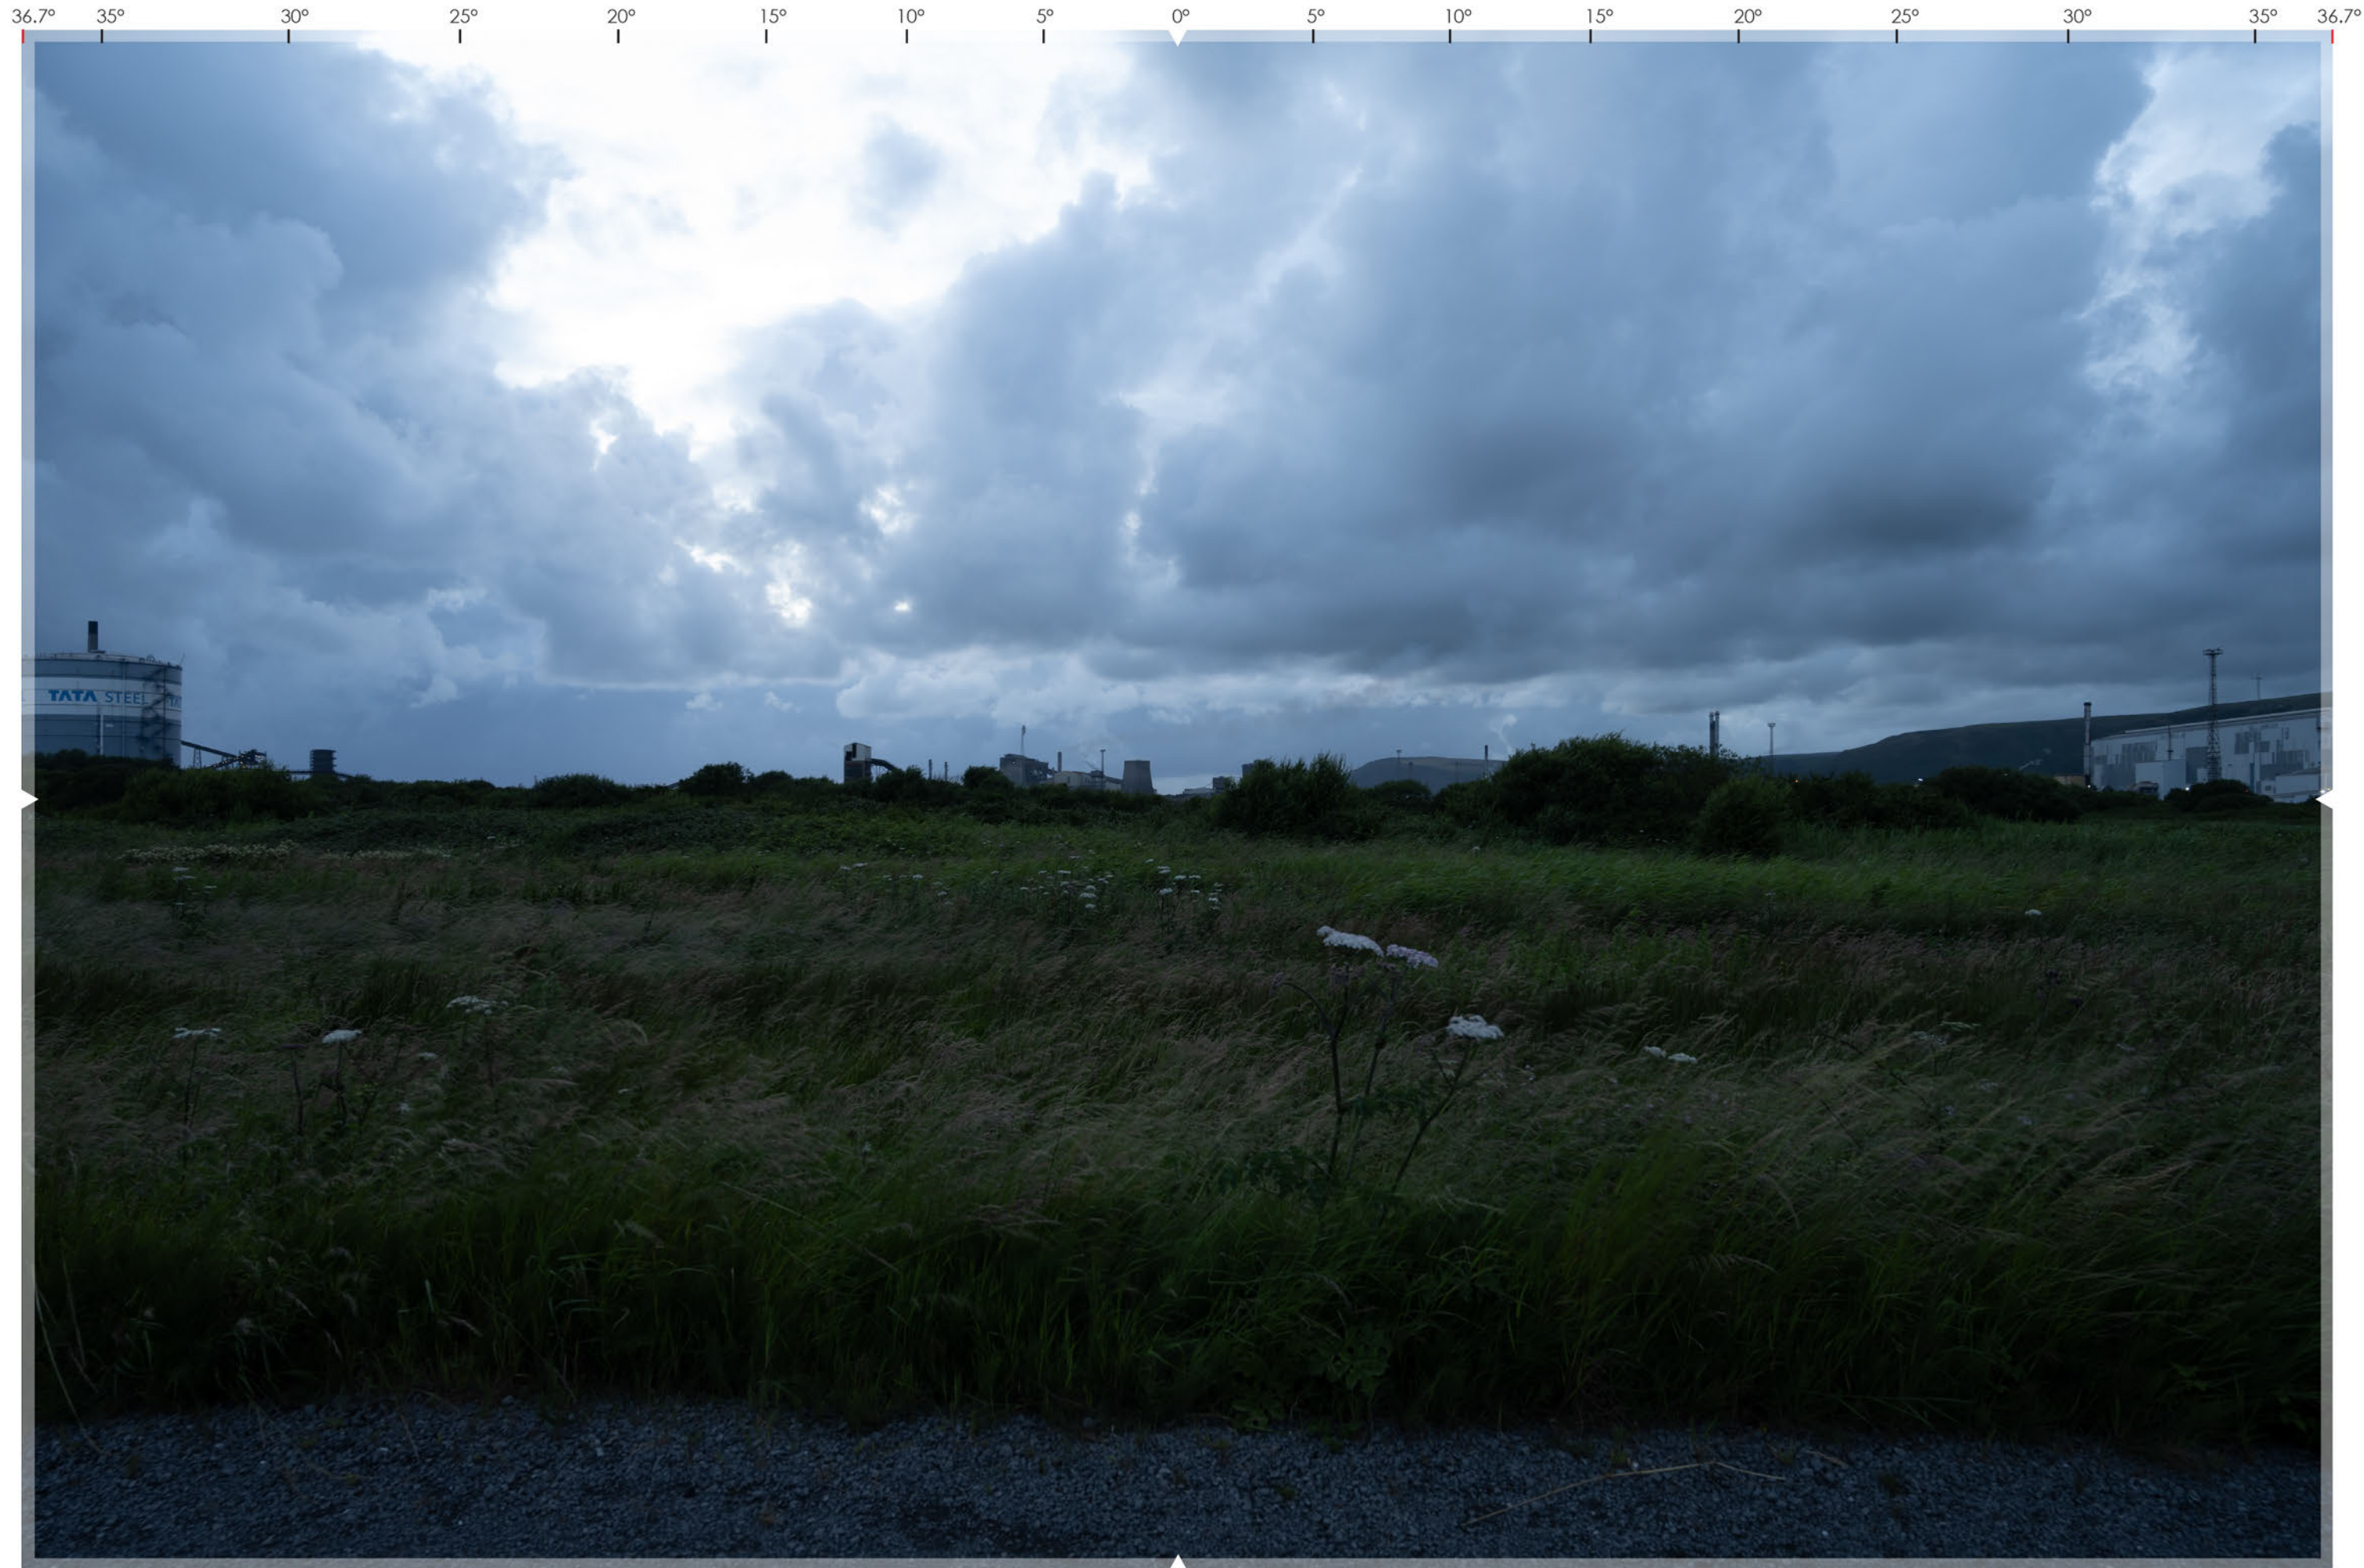
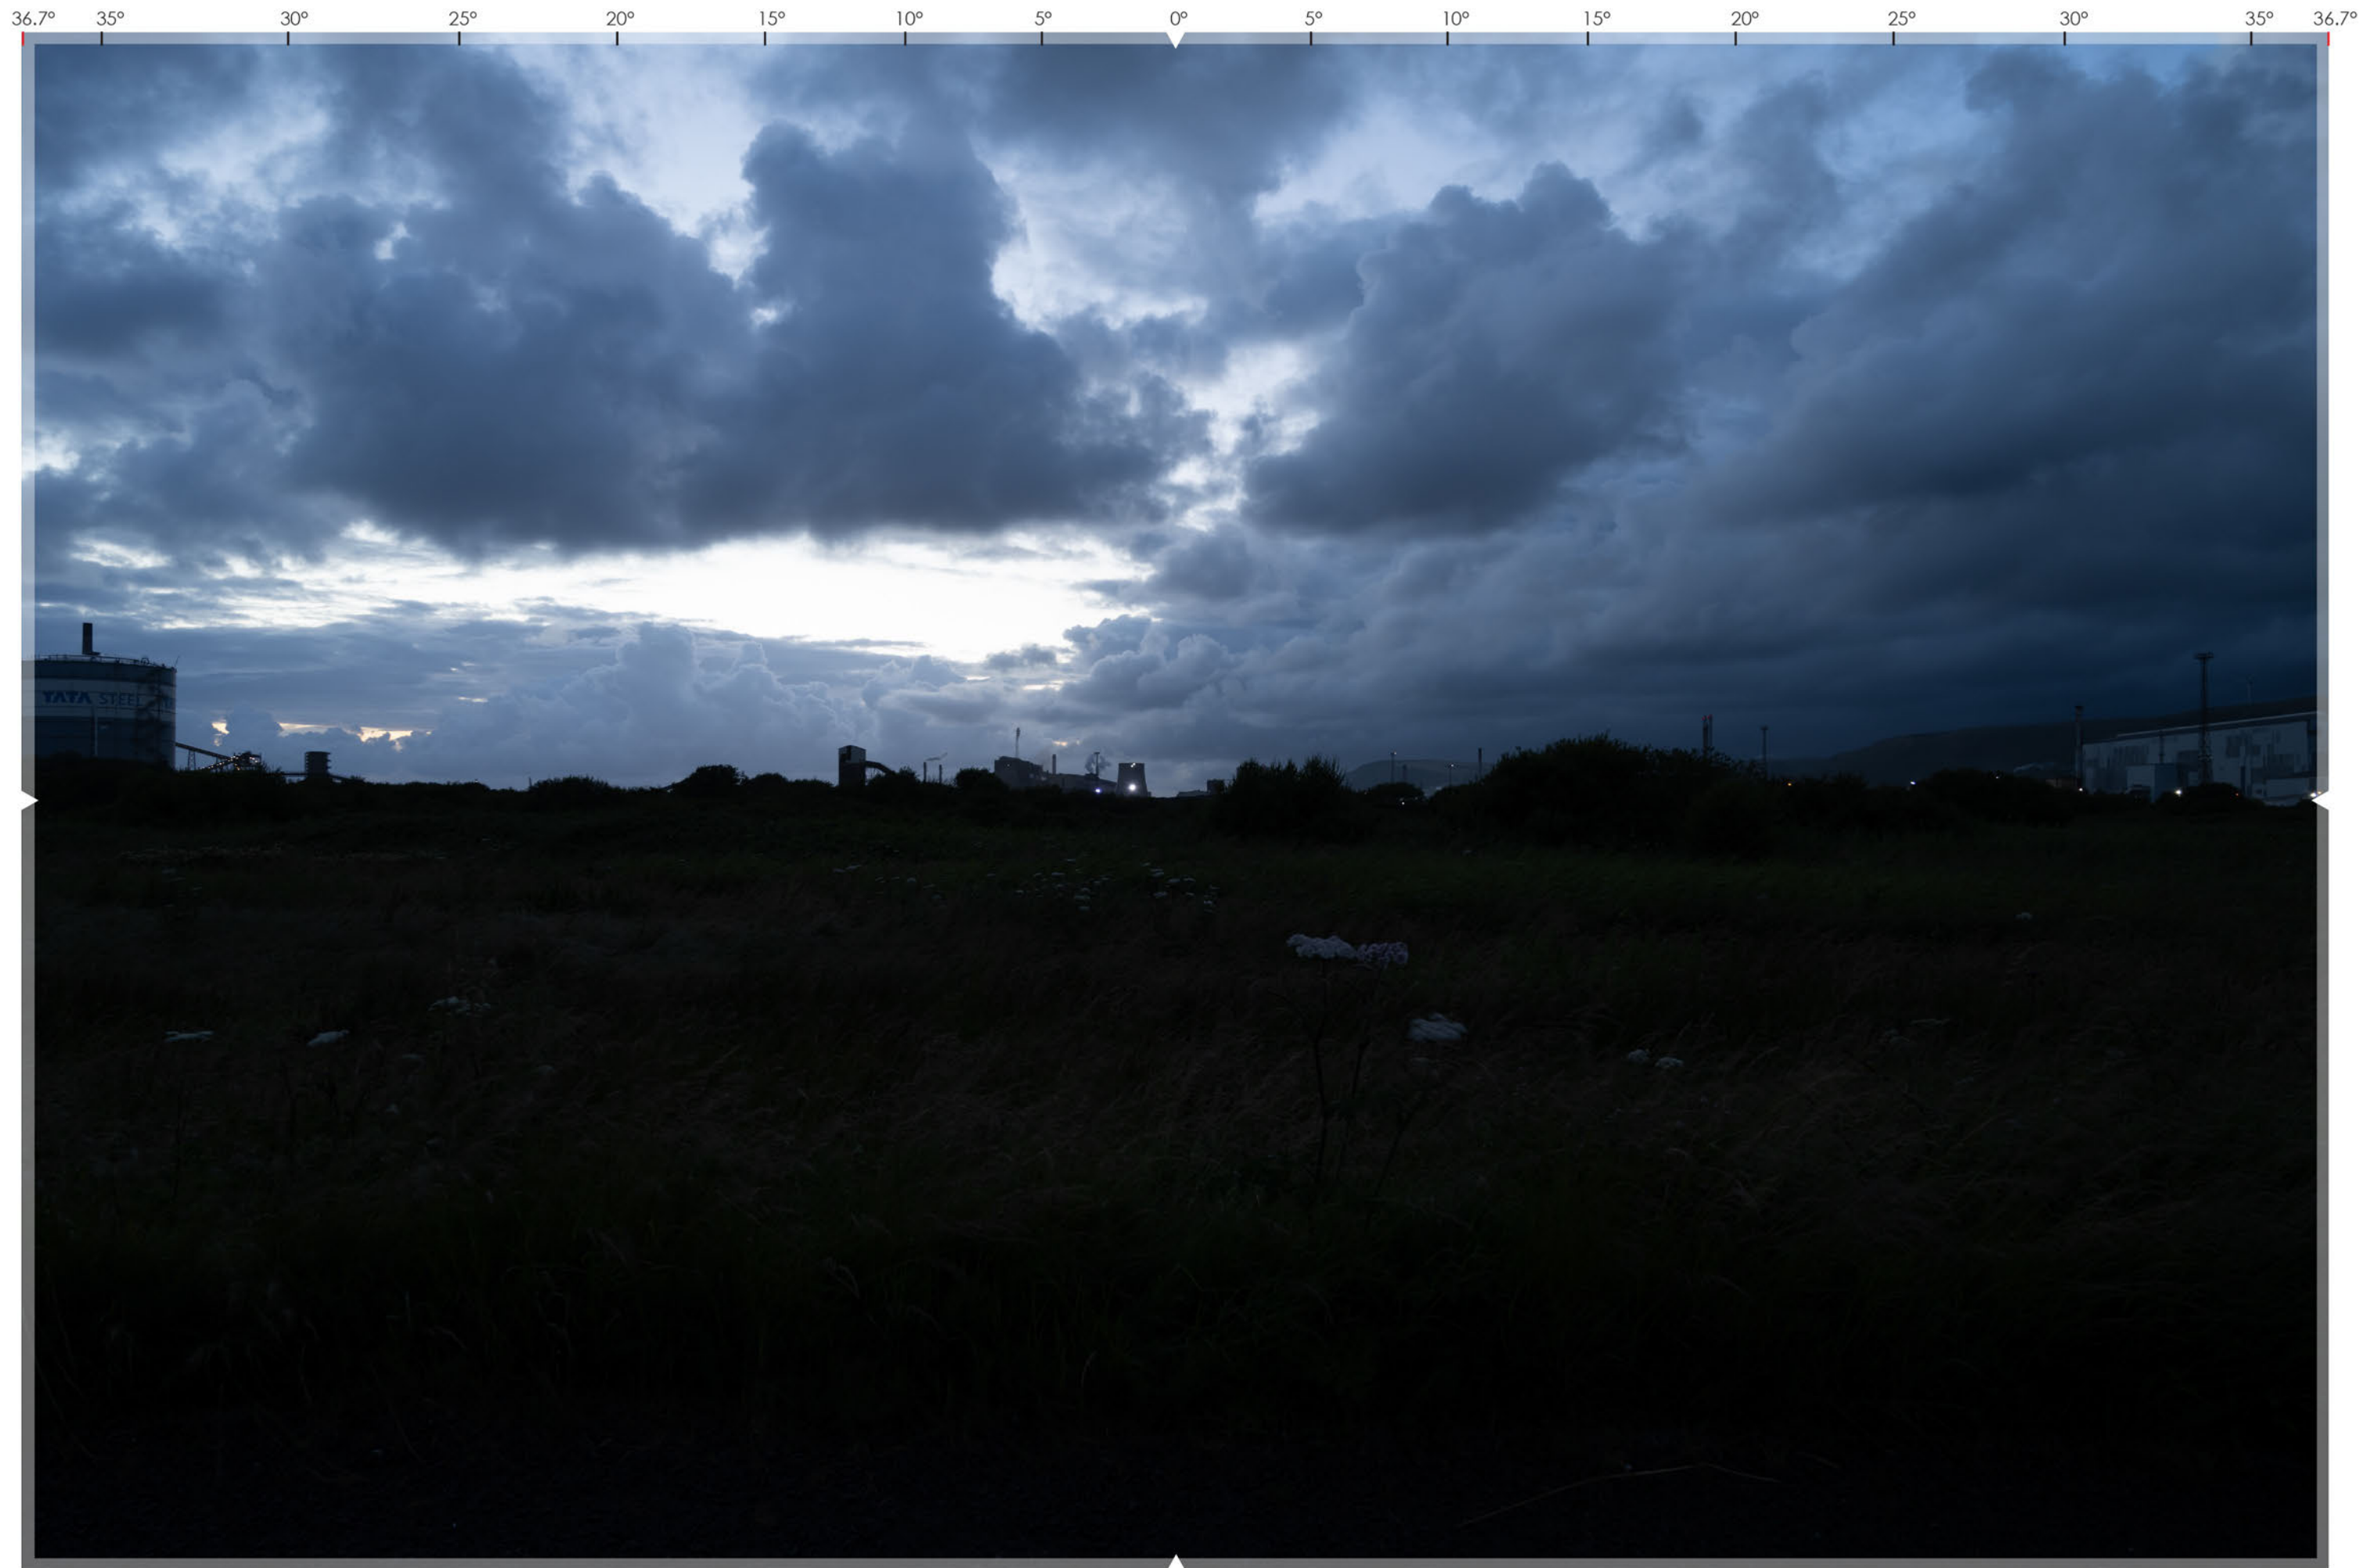
## VIEWPOINT 1, LONGLANDS LANE

278250.3875m (E), 185189.2581m (N), 4.7759m (AOD)

6 JULY 2024

Each viewpoint required 9x photographs to capture the passage of natural light from the end of day through sunset, dusk, twilight and then night-time. During the time of shooting in July, shots were taken from roughly 2015 hours through to 2330 hours.
