# Port Talbot

Light Pollution Study

15 July 2024

## 1. Executive Summary

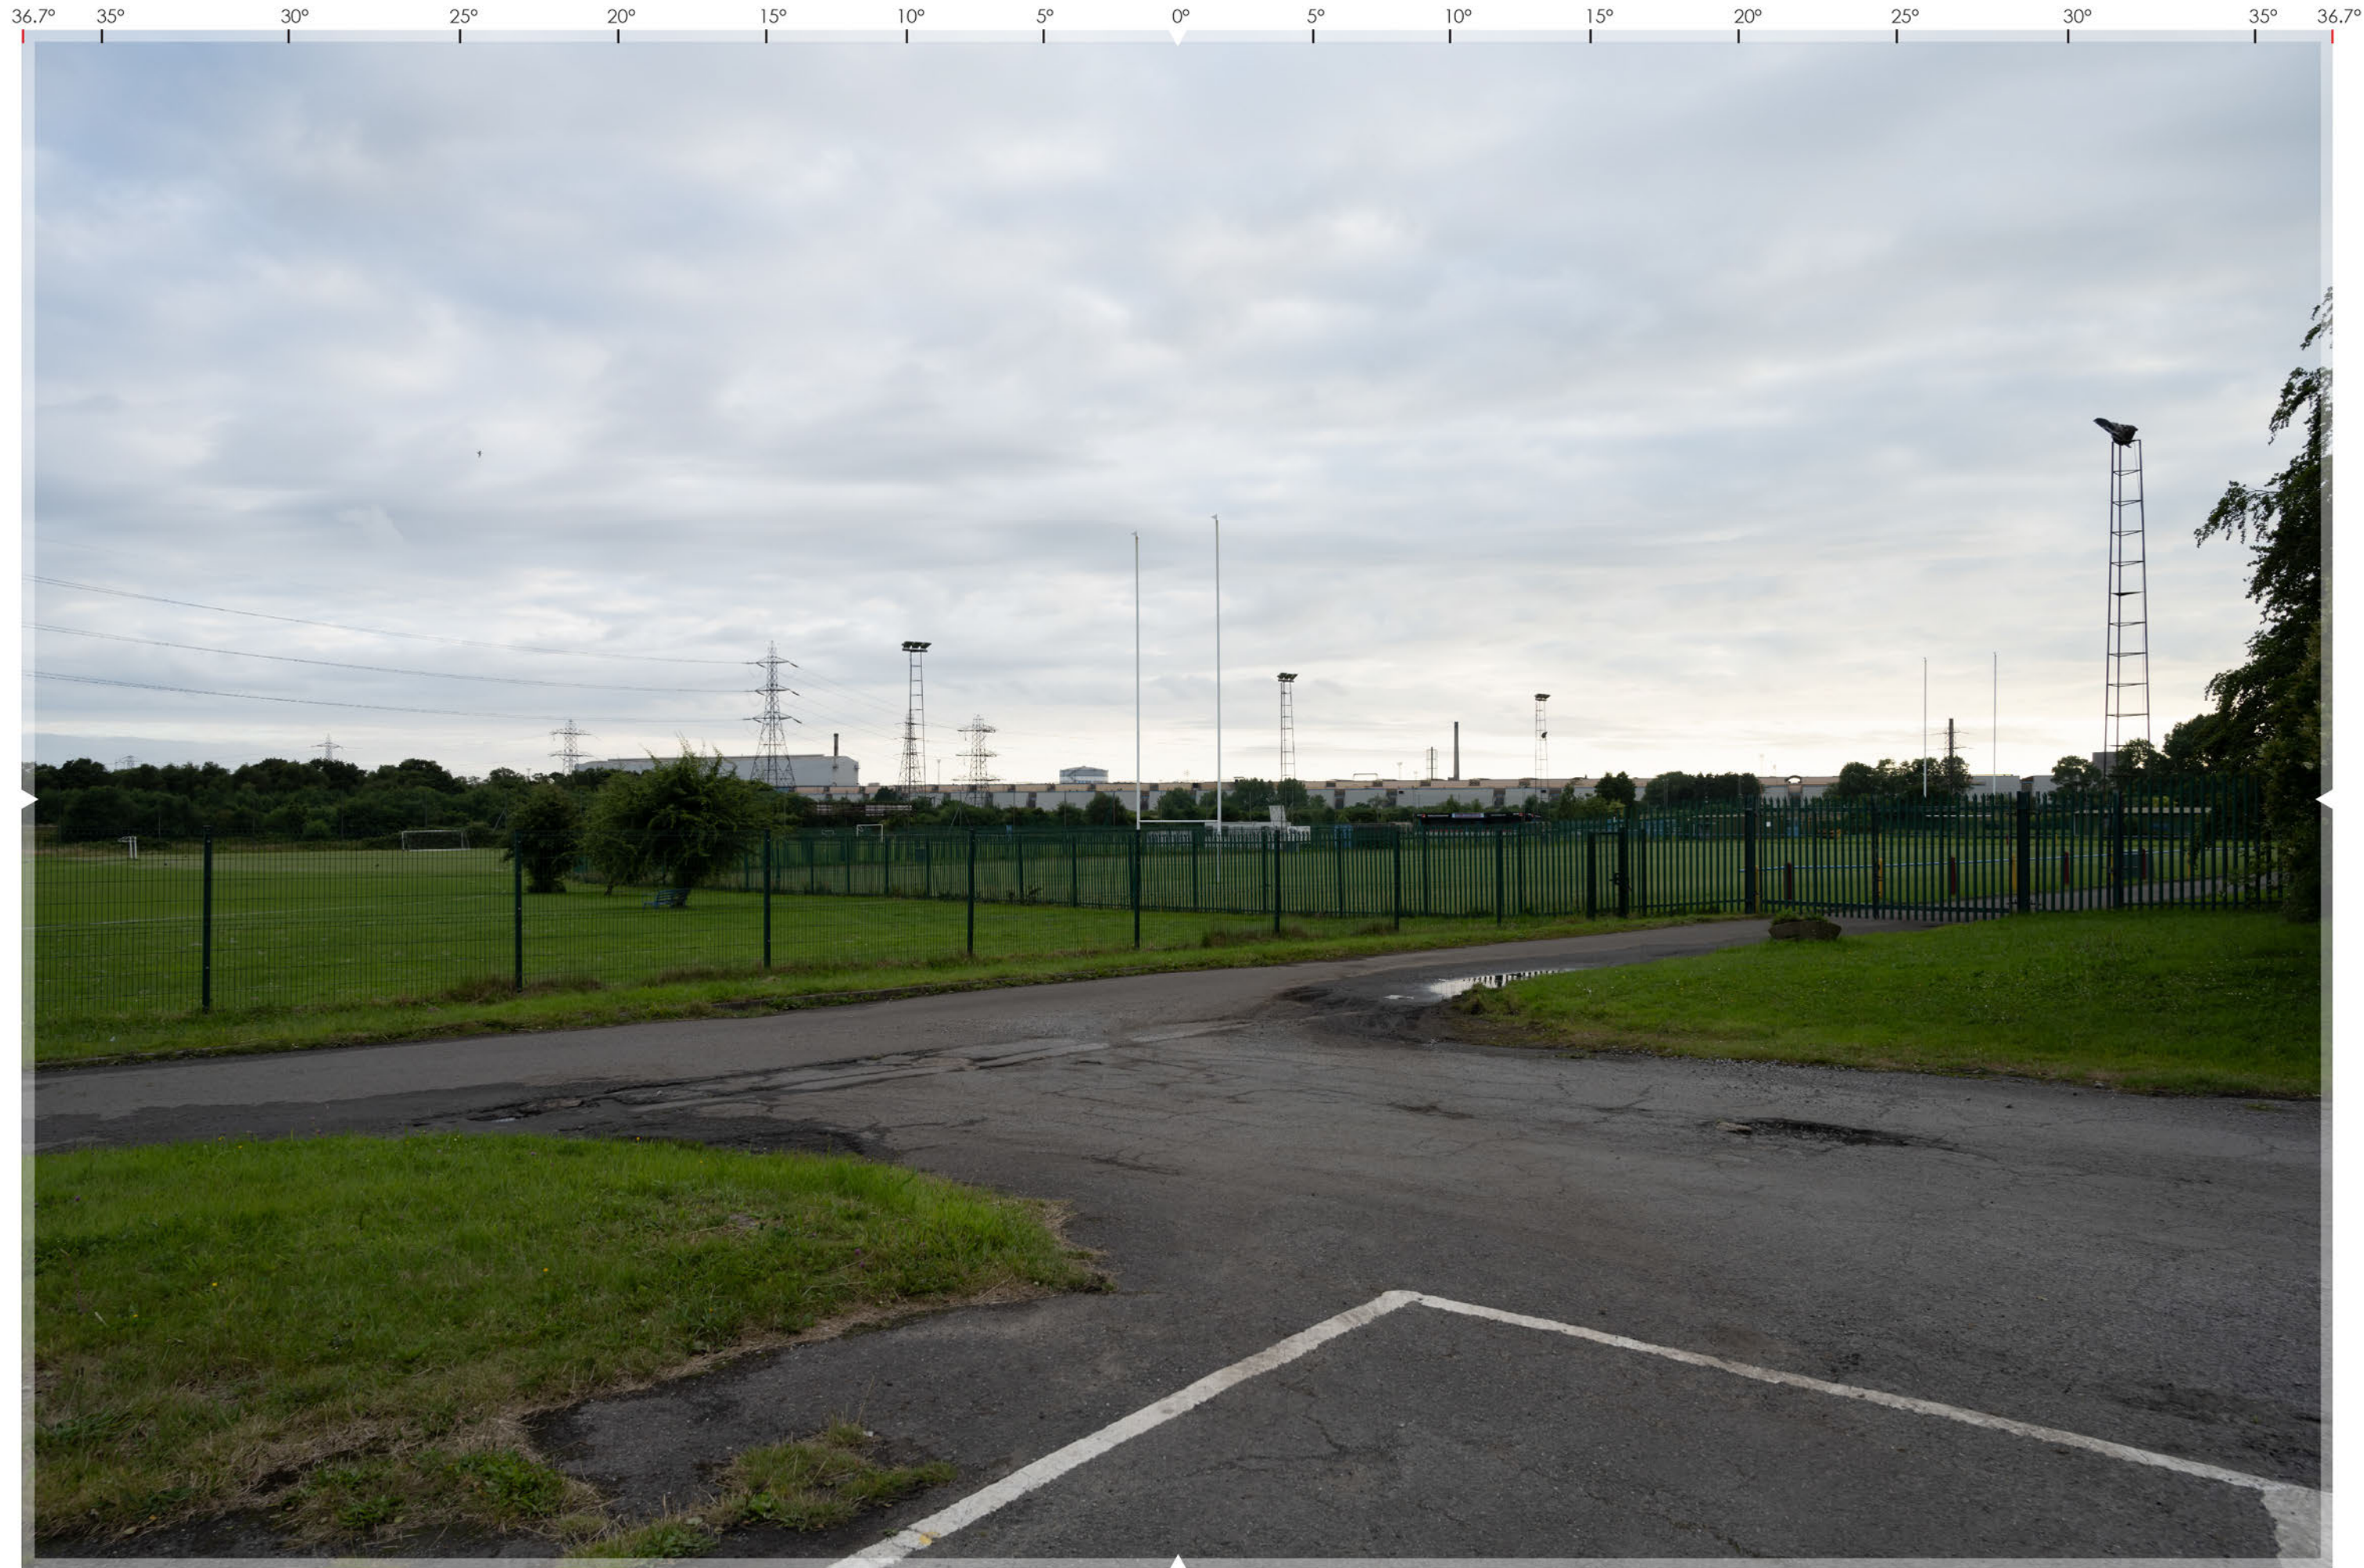
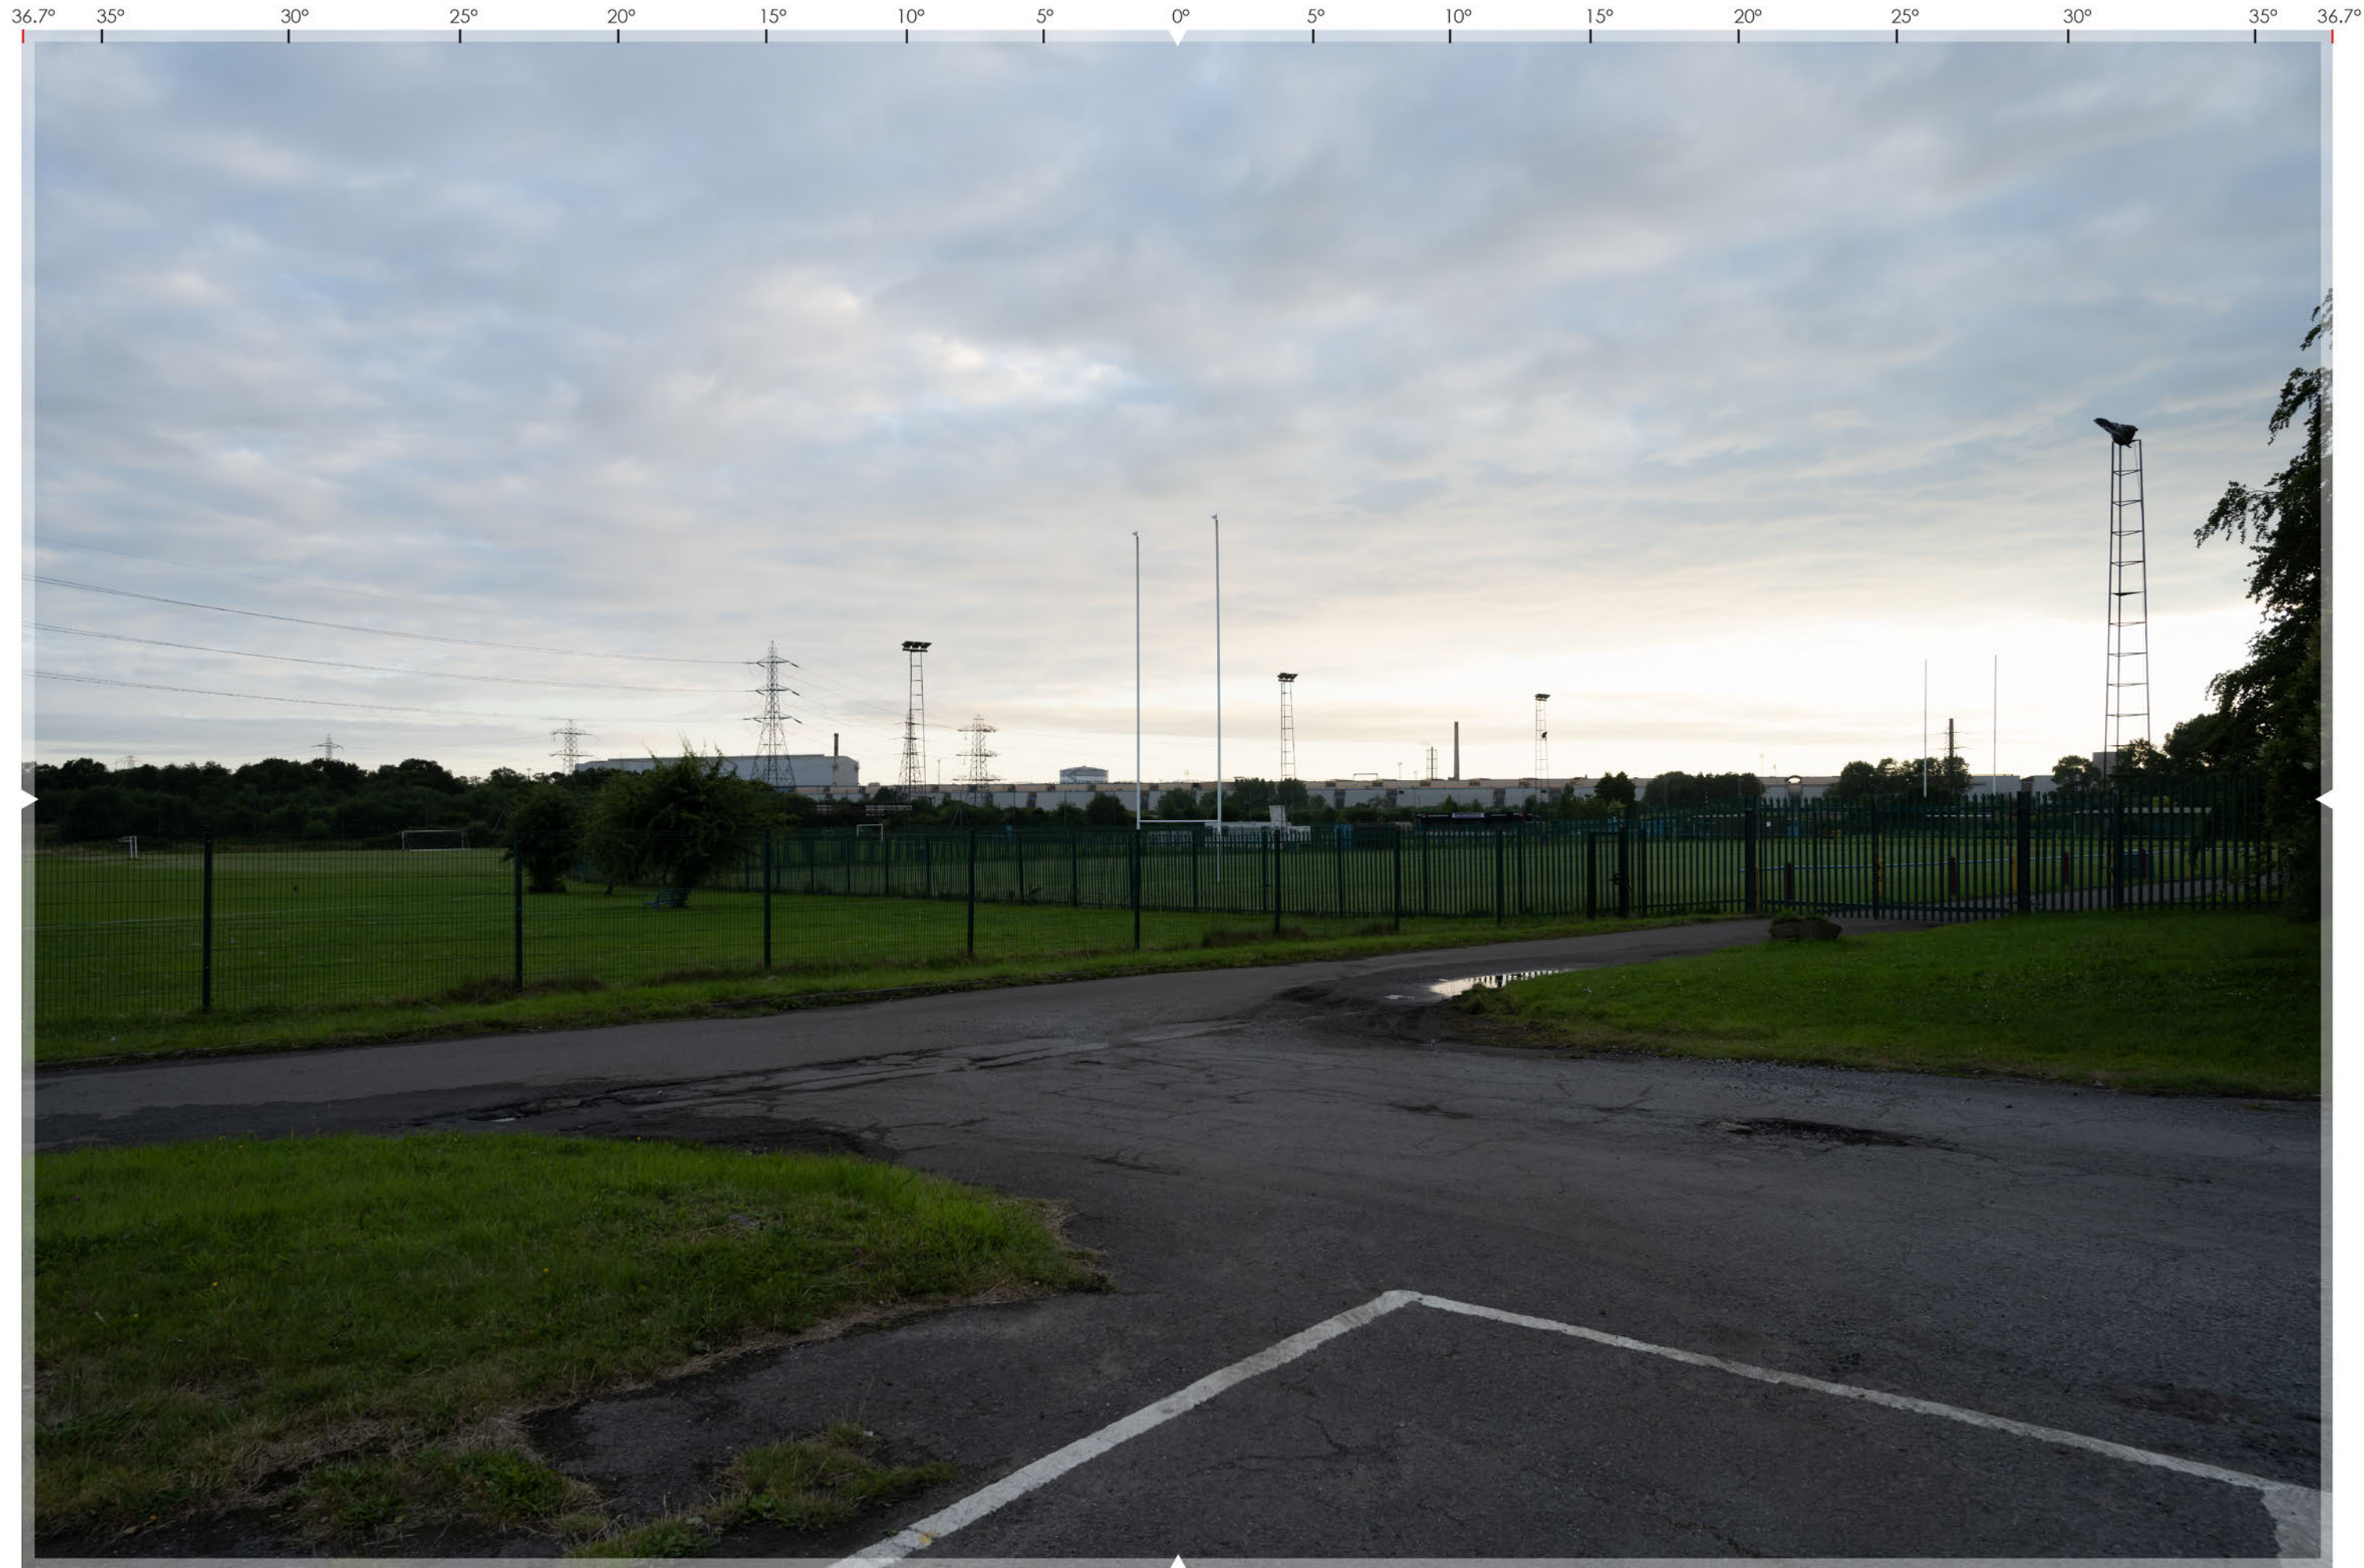
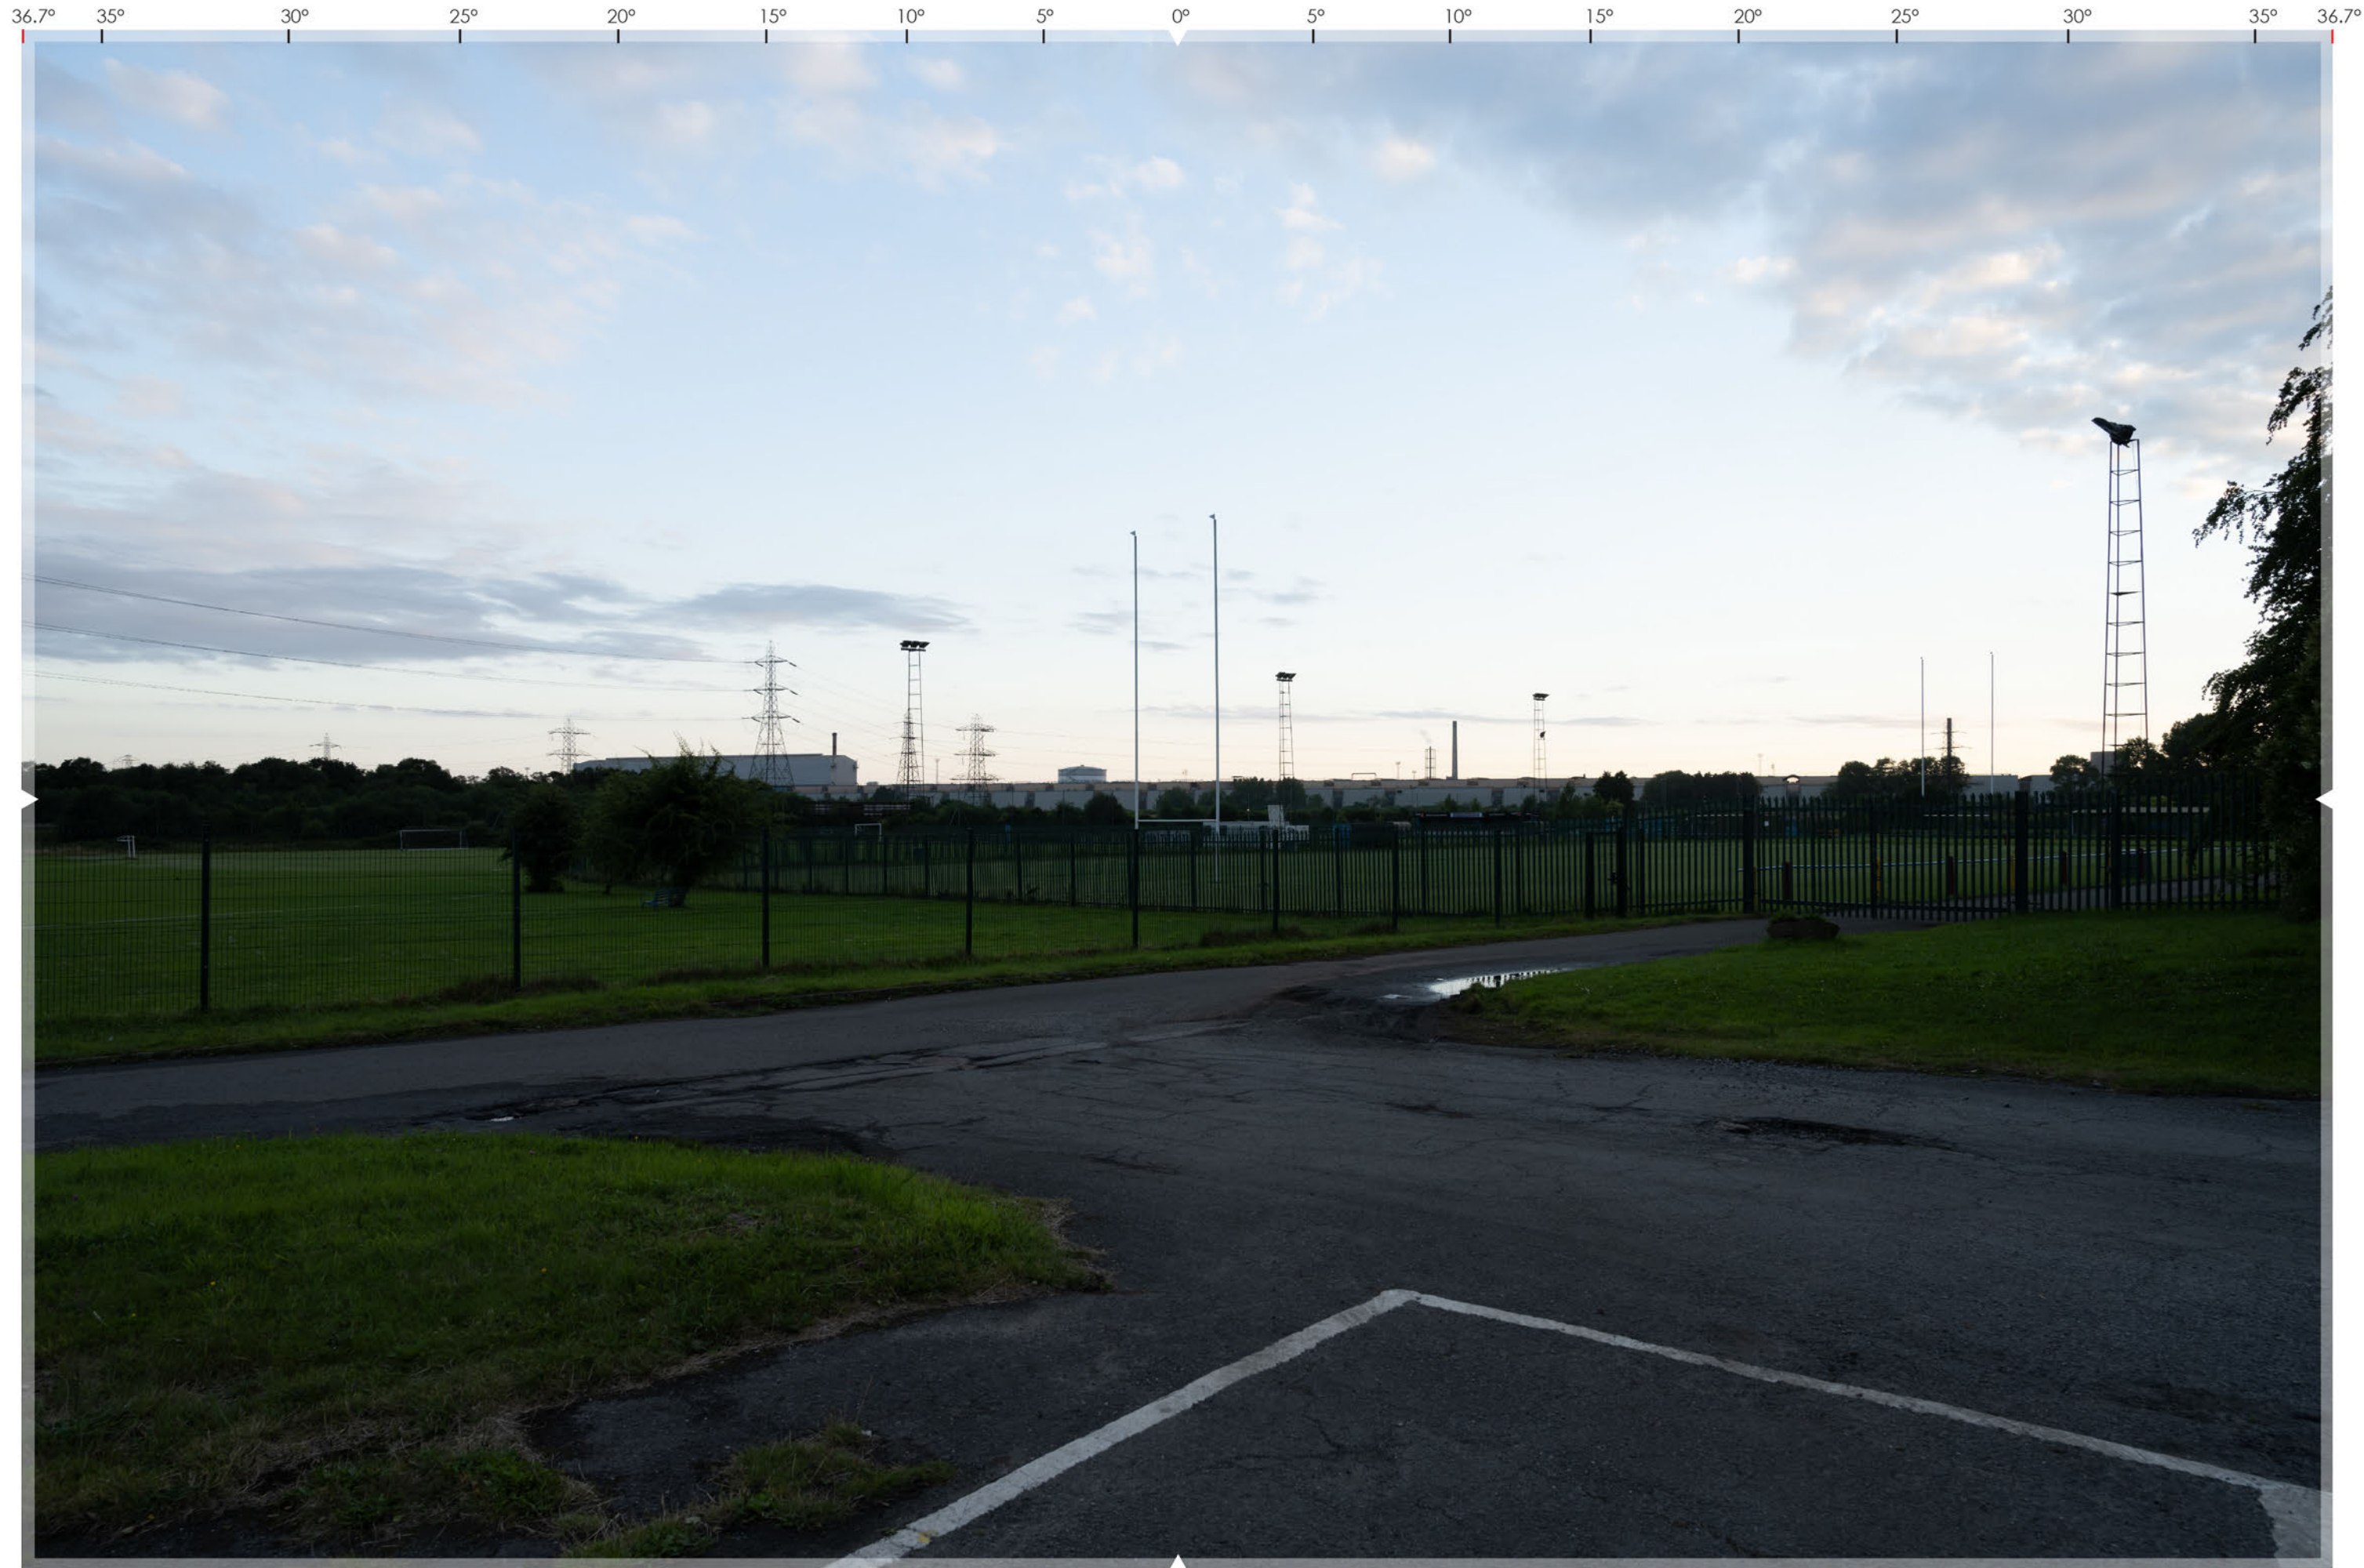
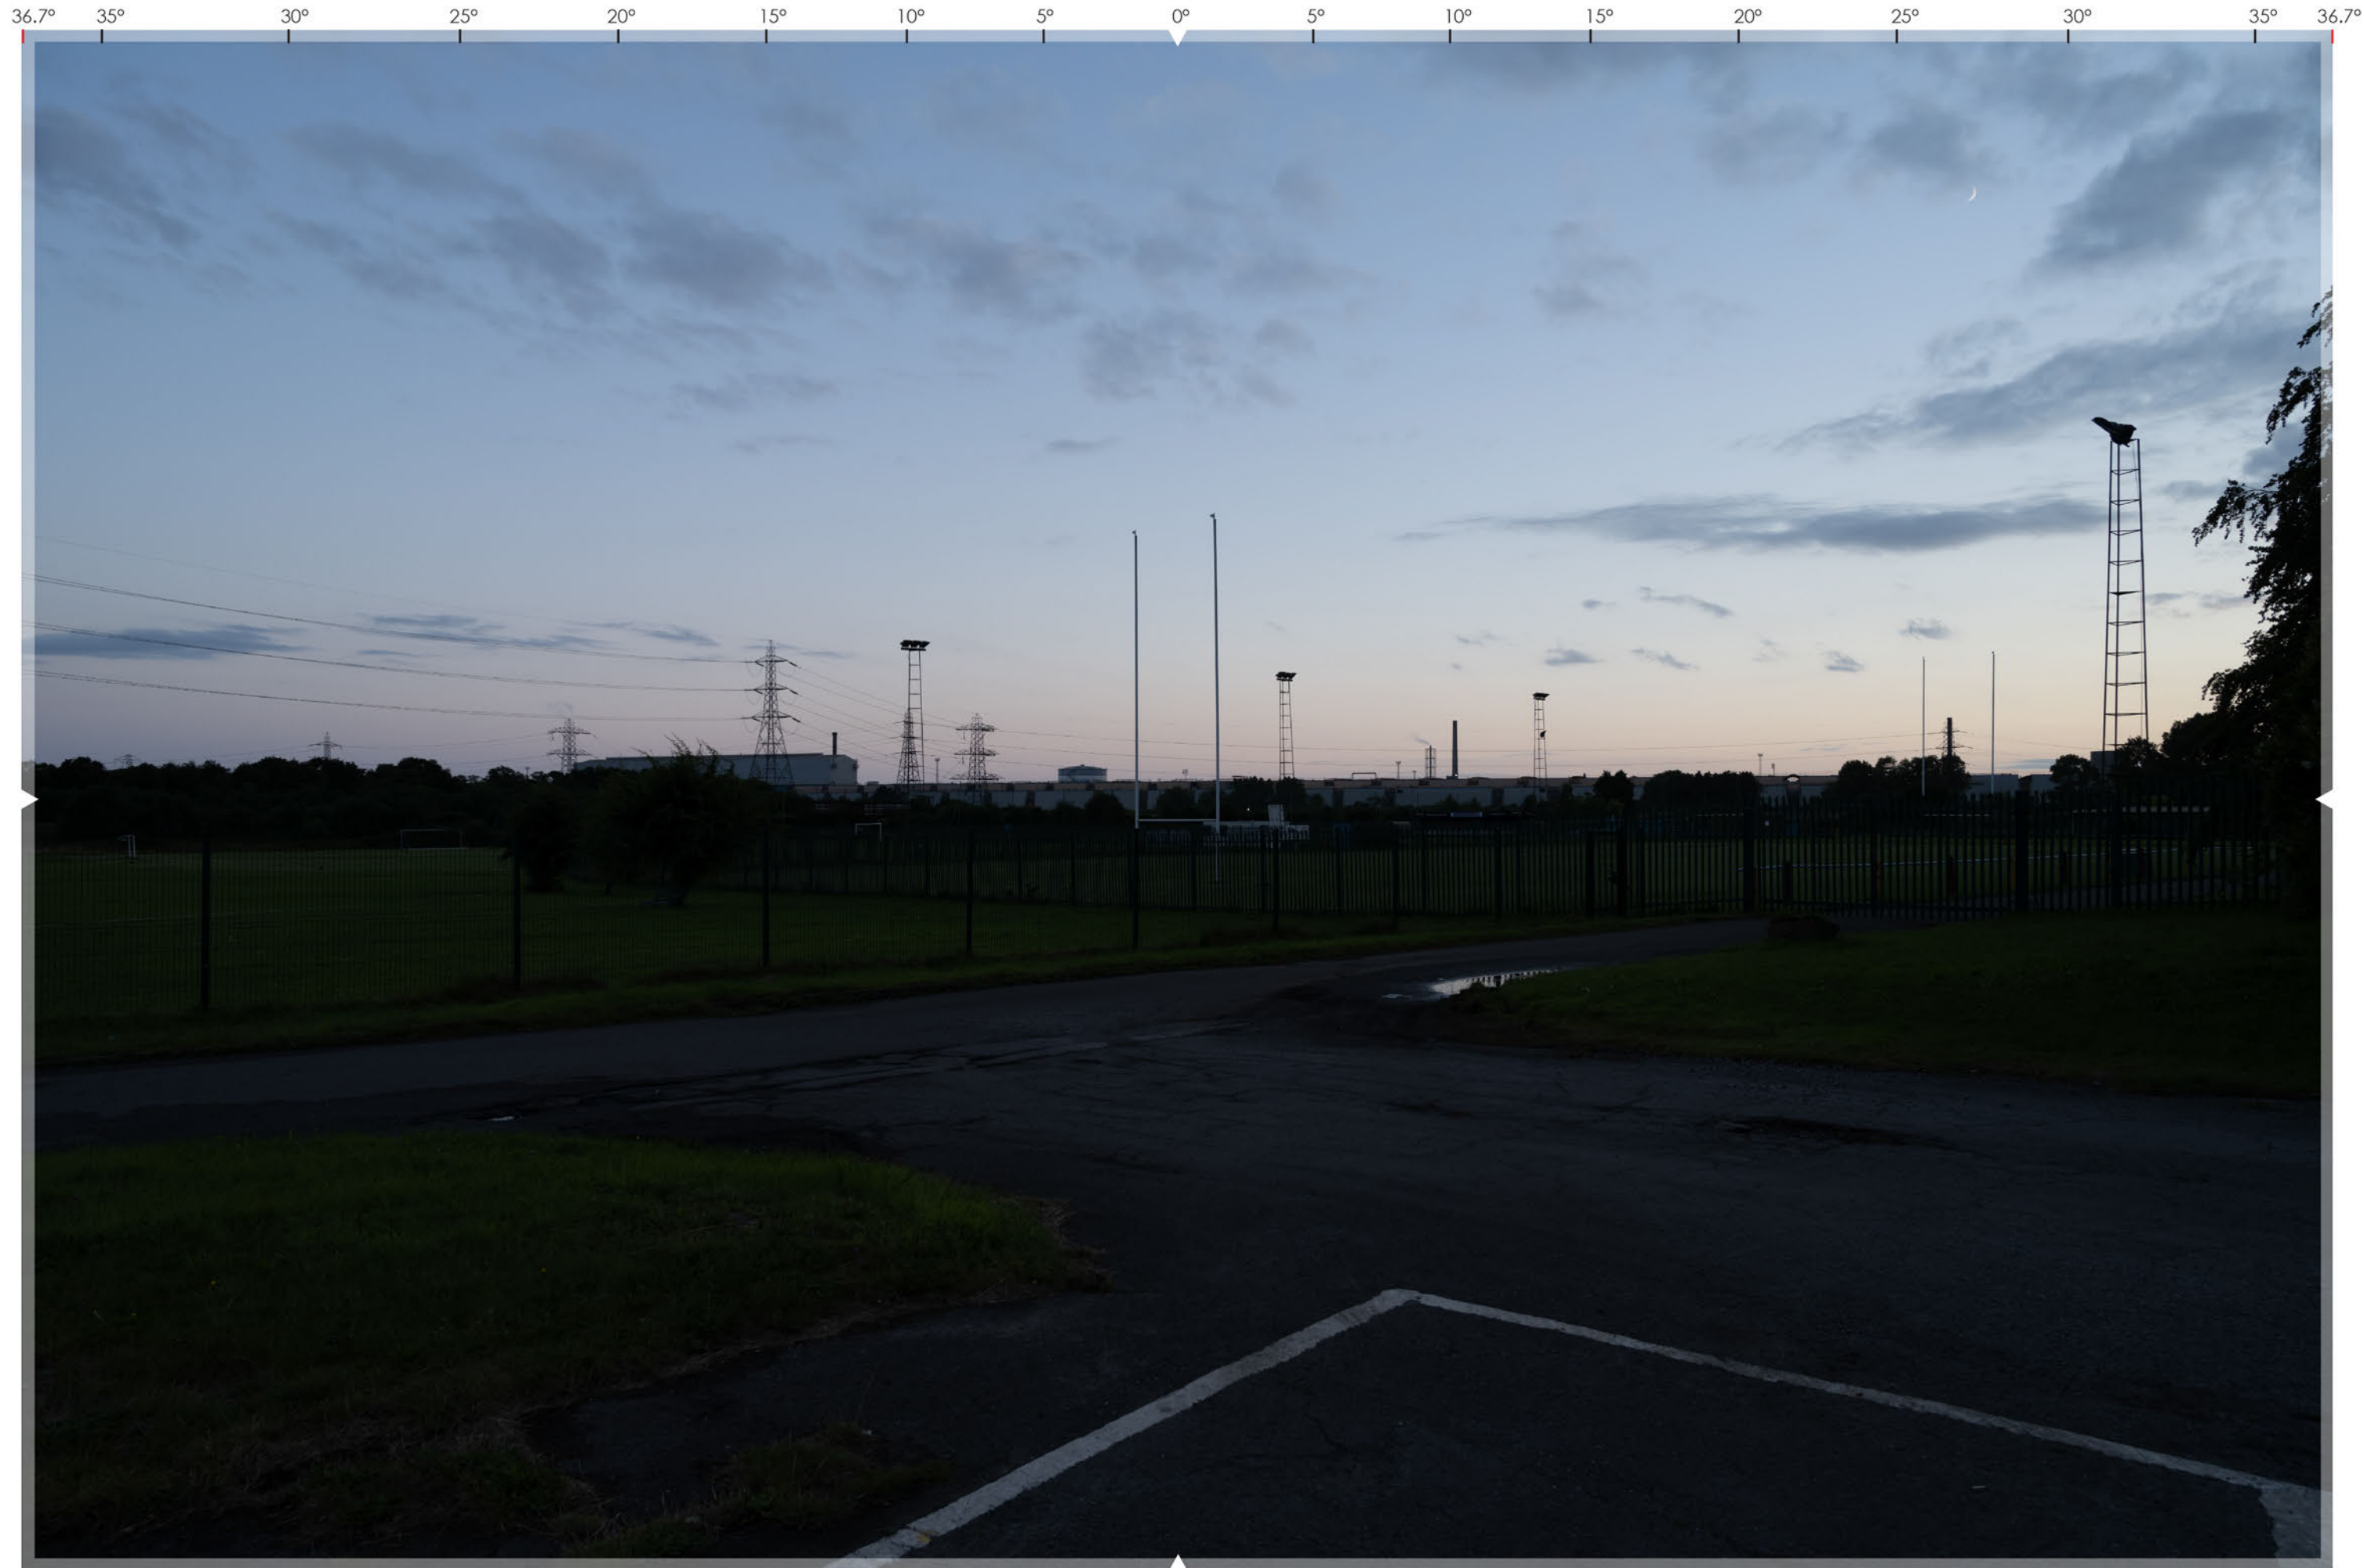
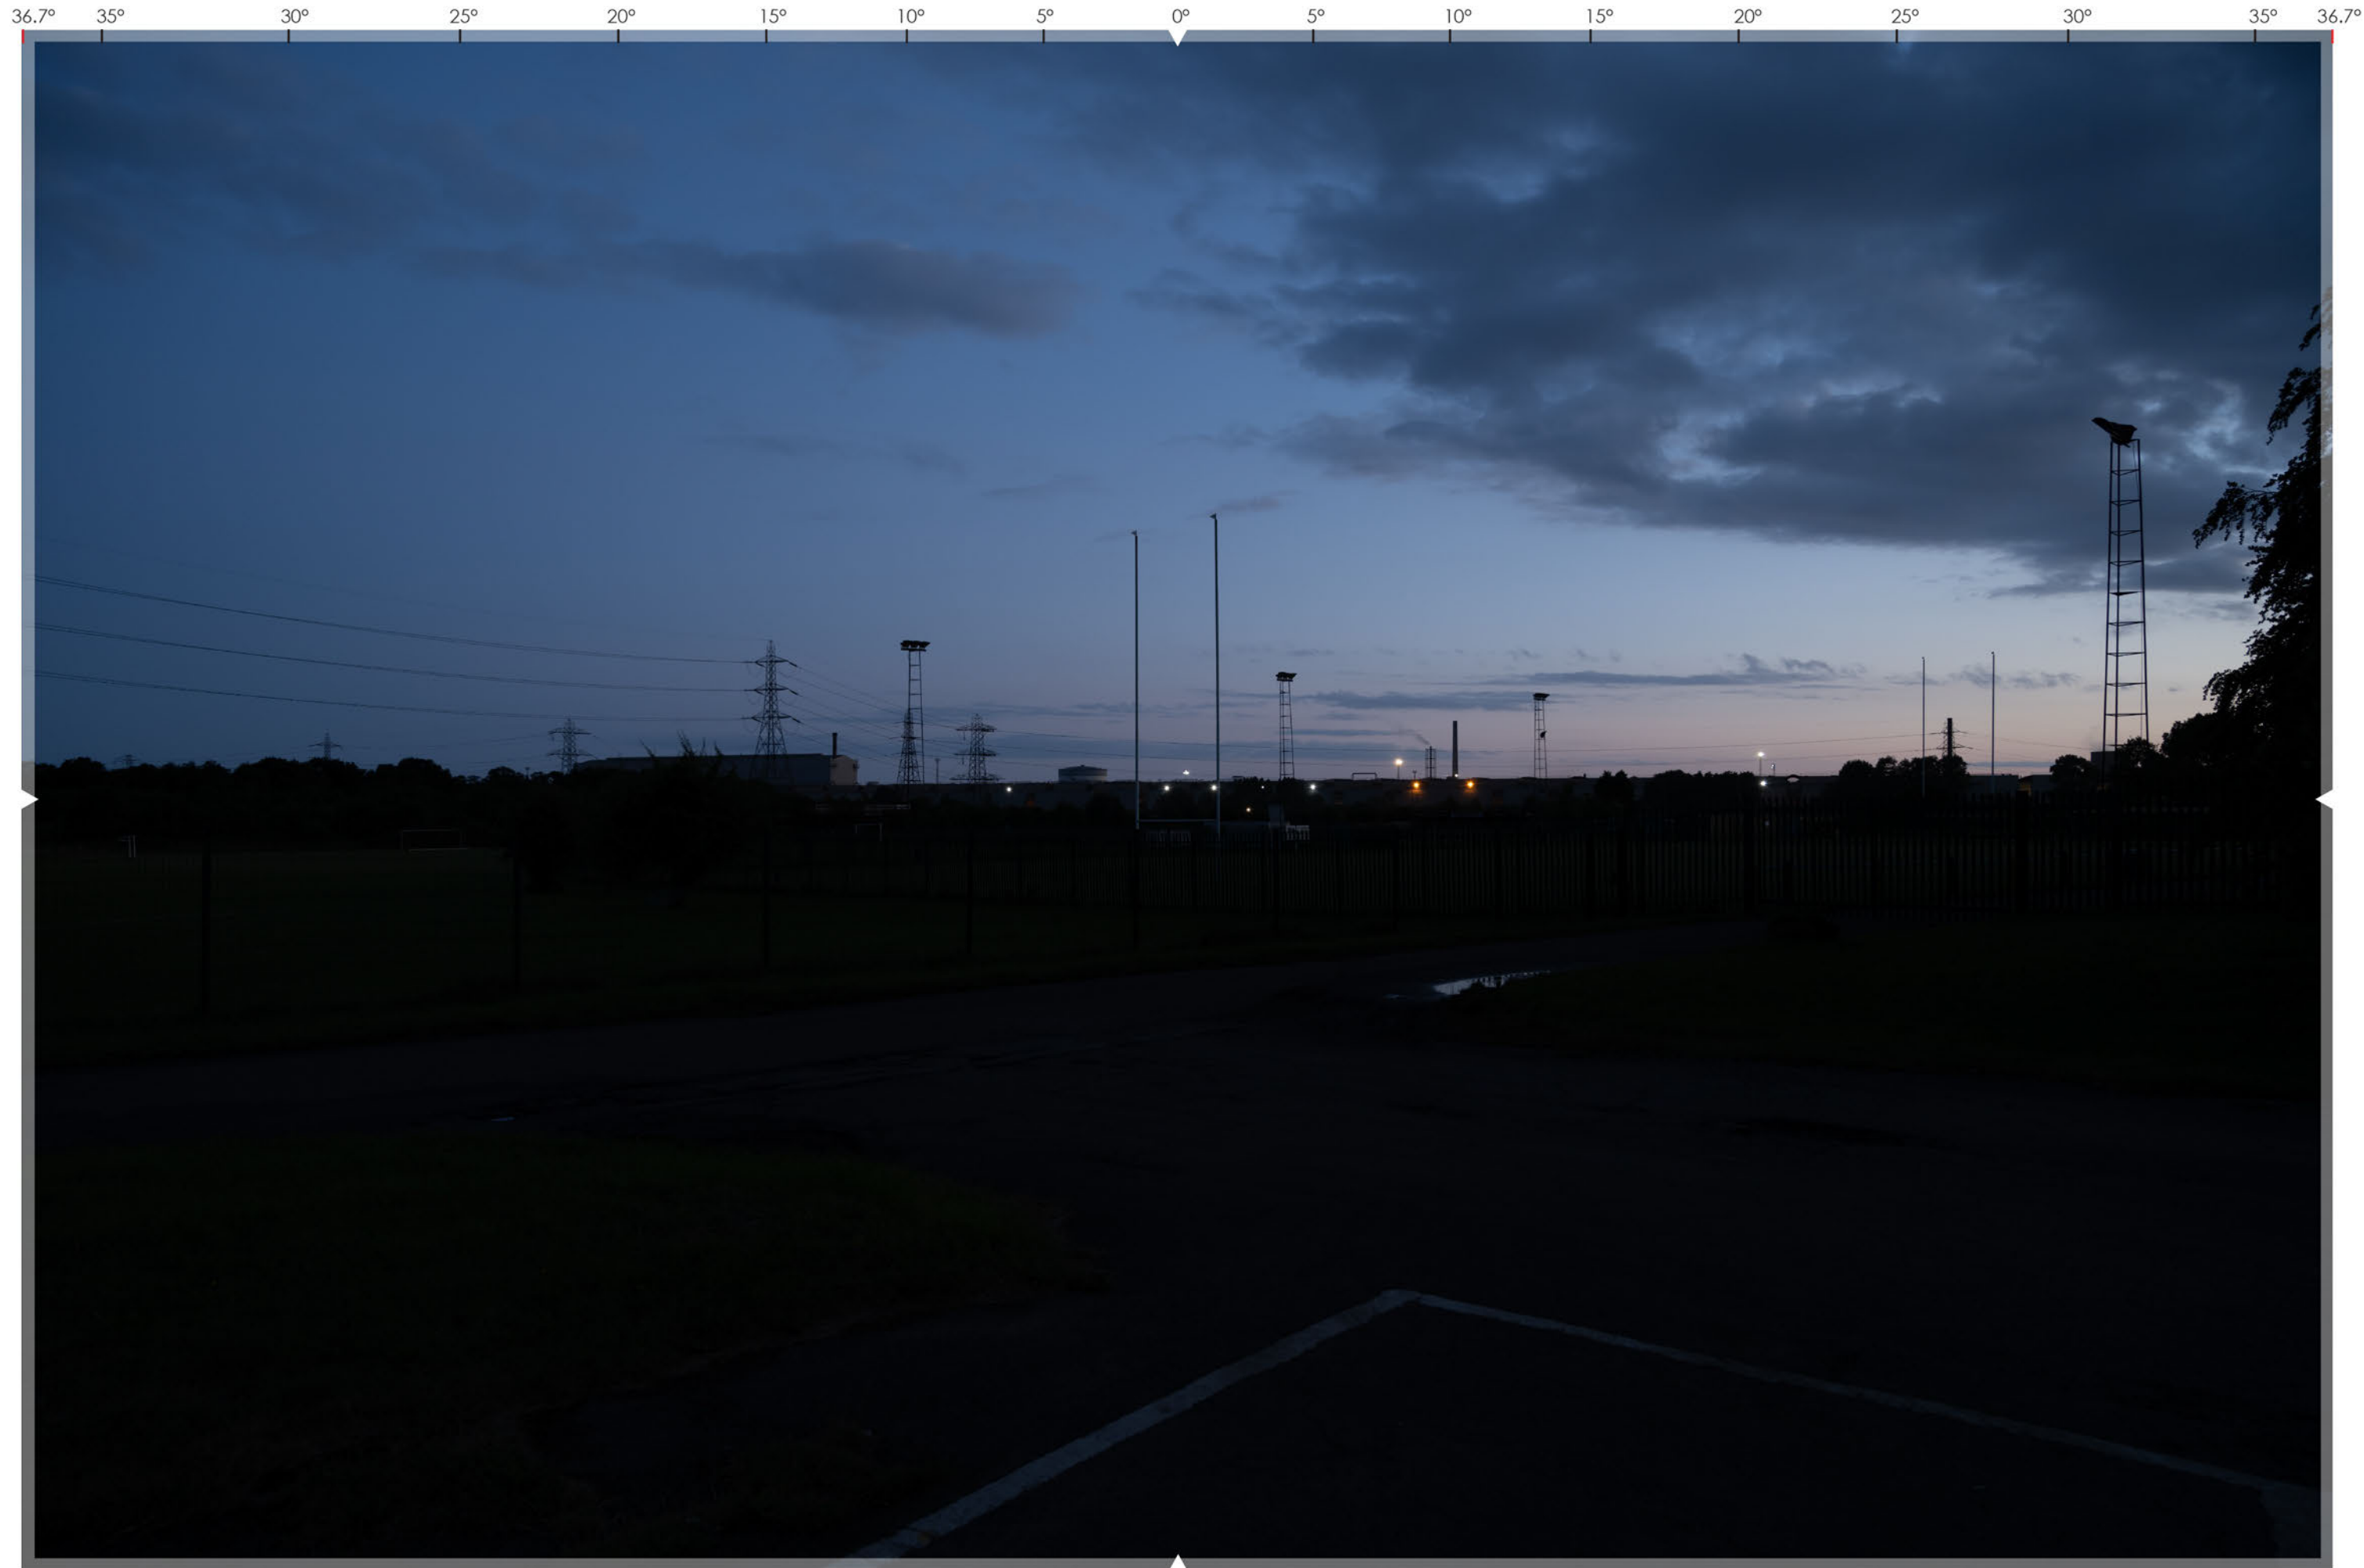
VIEWPOINT 2, ABBOTS CLOSE, MARGAM

278900.6560m (E), 186867.2878m (N), 6.8647m (AOD)

10 JULY 2024

Each viewpoint required 9x photographs to capture the passage of natural light from the end of day through sunset, dusk, twilight and then night-time. During the time of shooting in July, shots were taken from roughly 2015 hours through to 2330 hours.
