# Port Talbot

Light Pollution Study

15 July 2024

## 1. Executive Summary

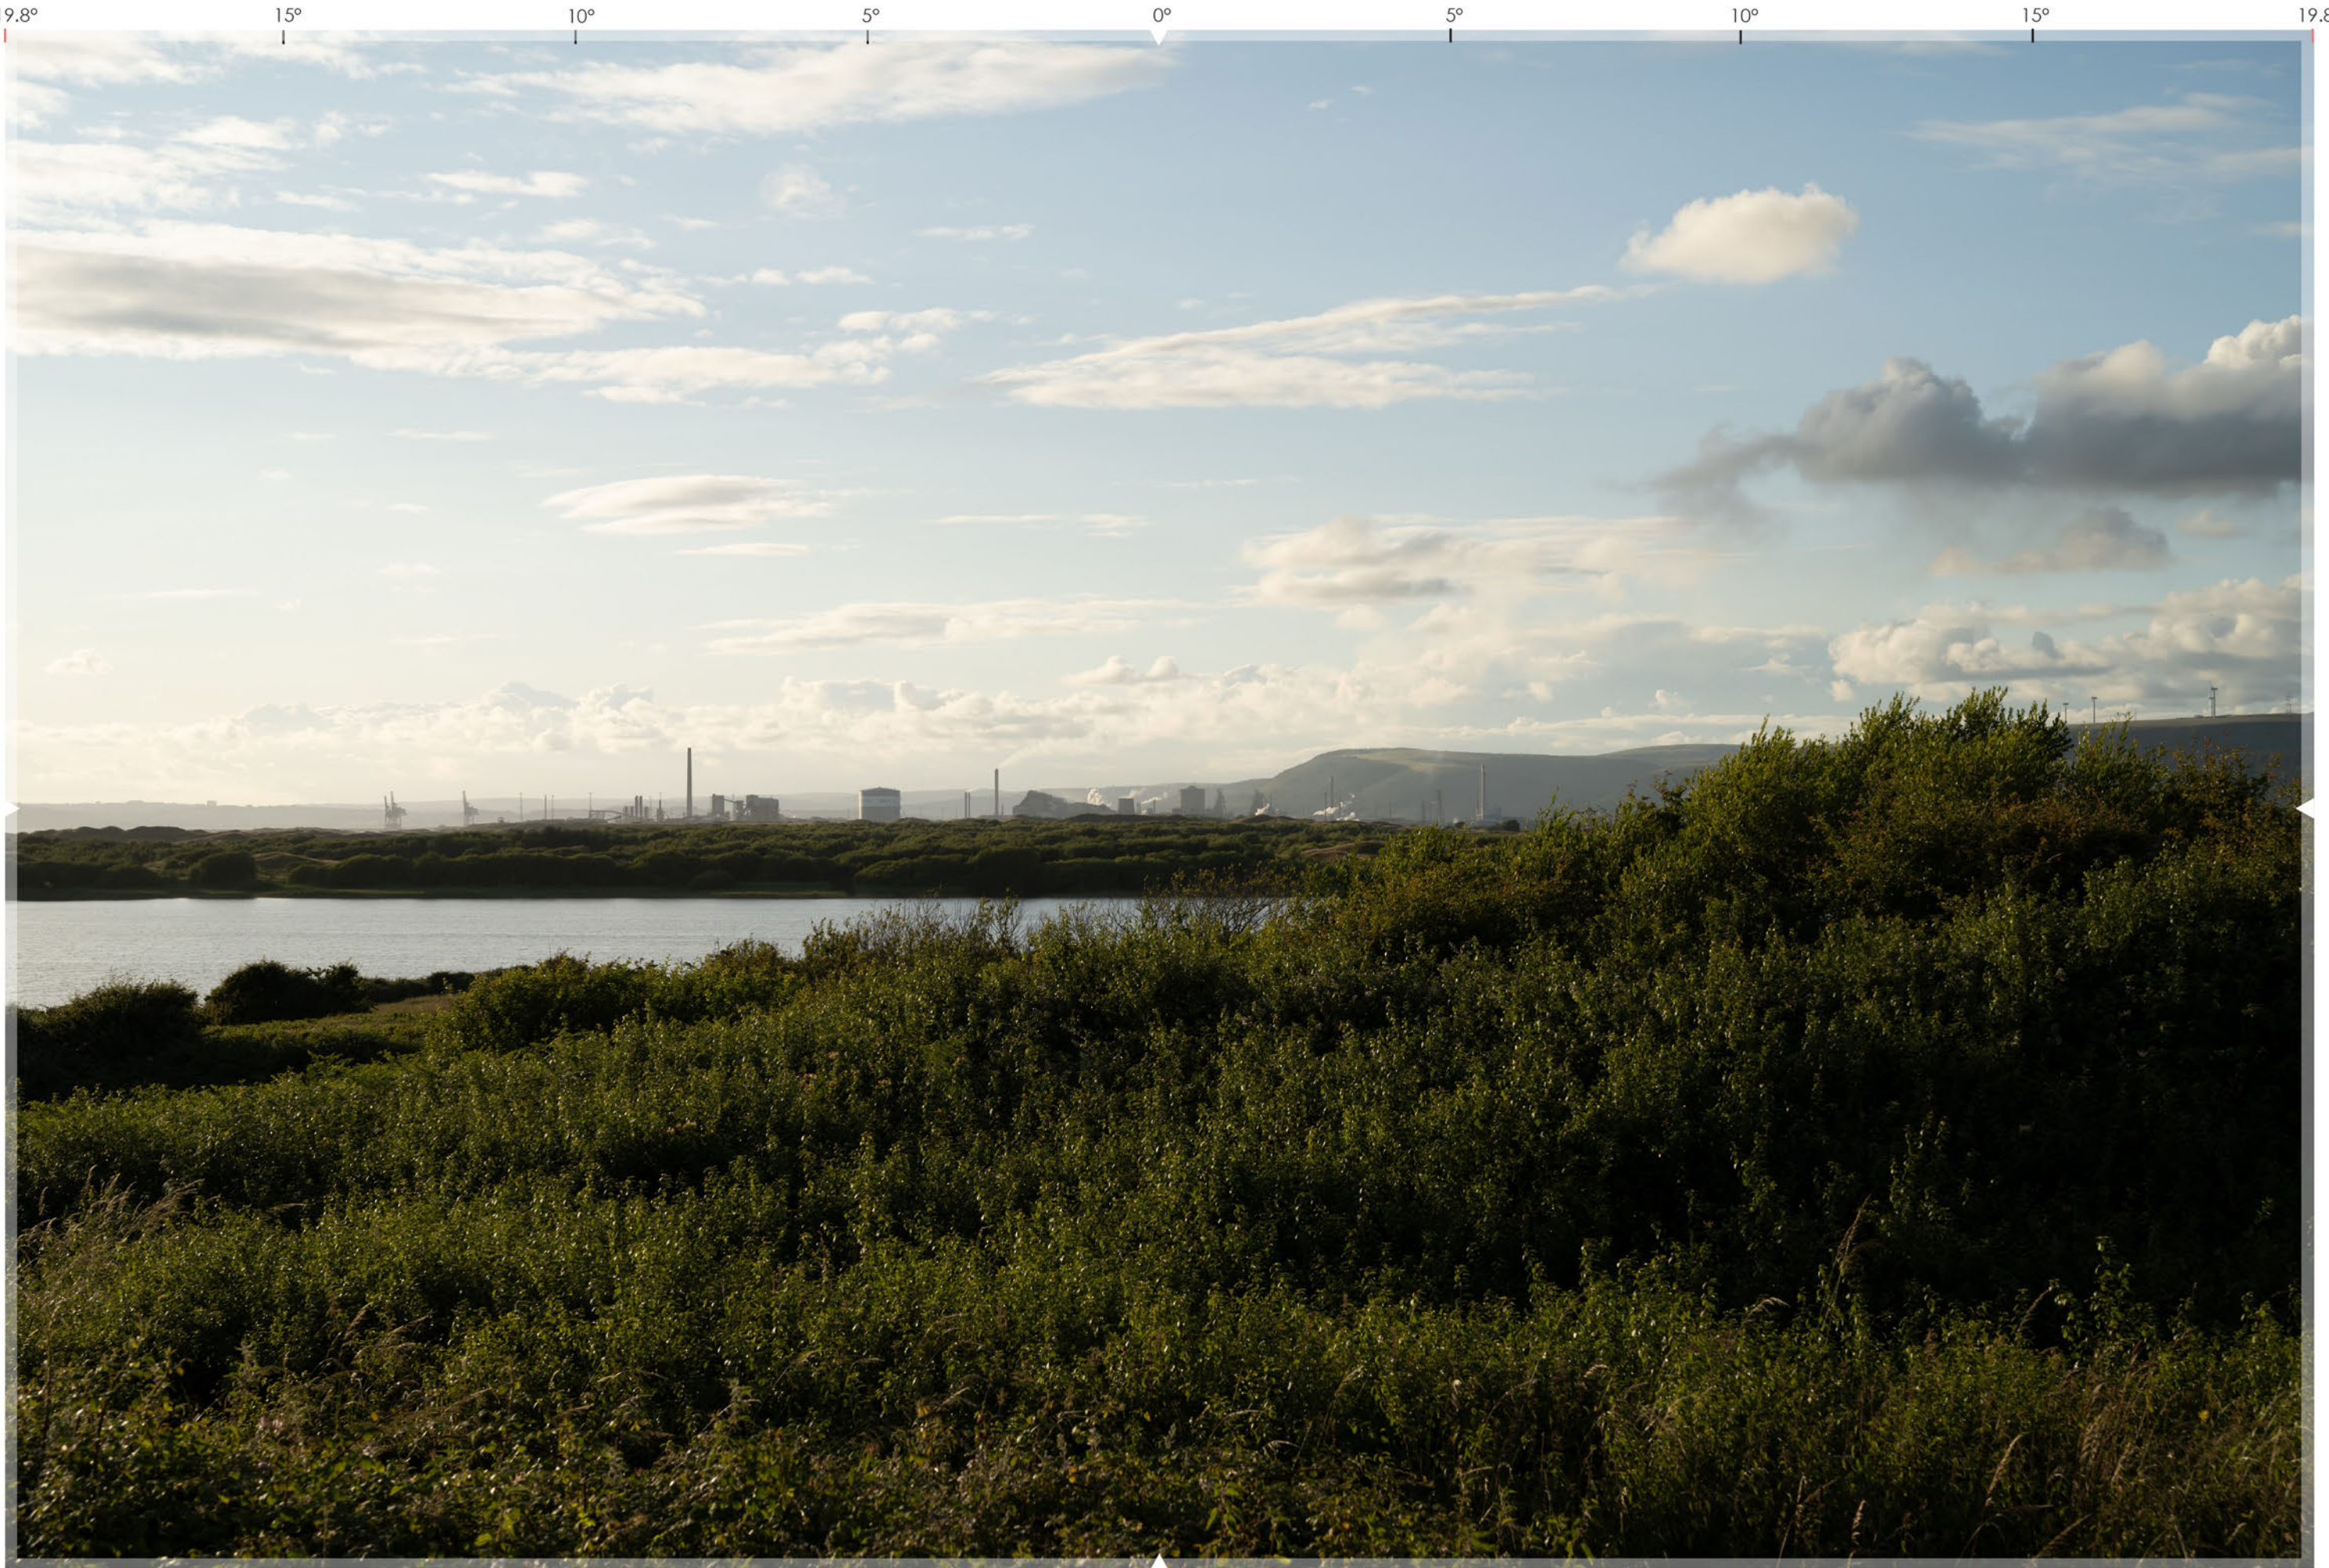
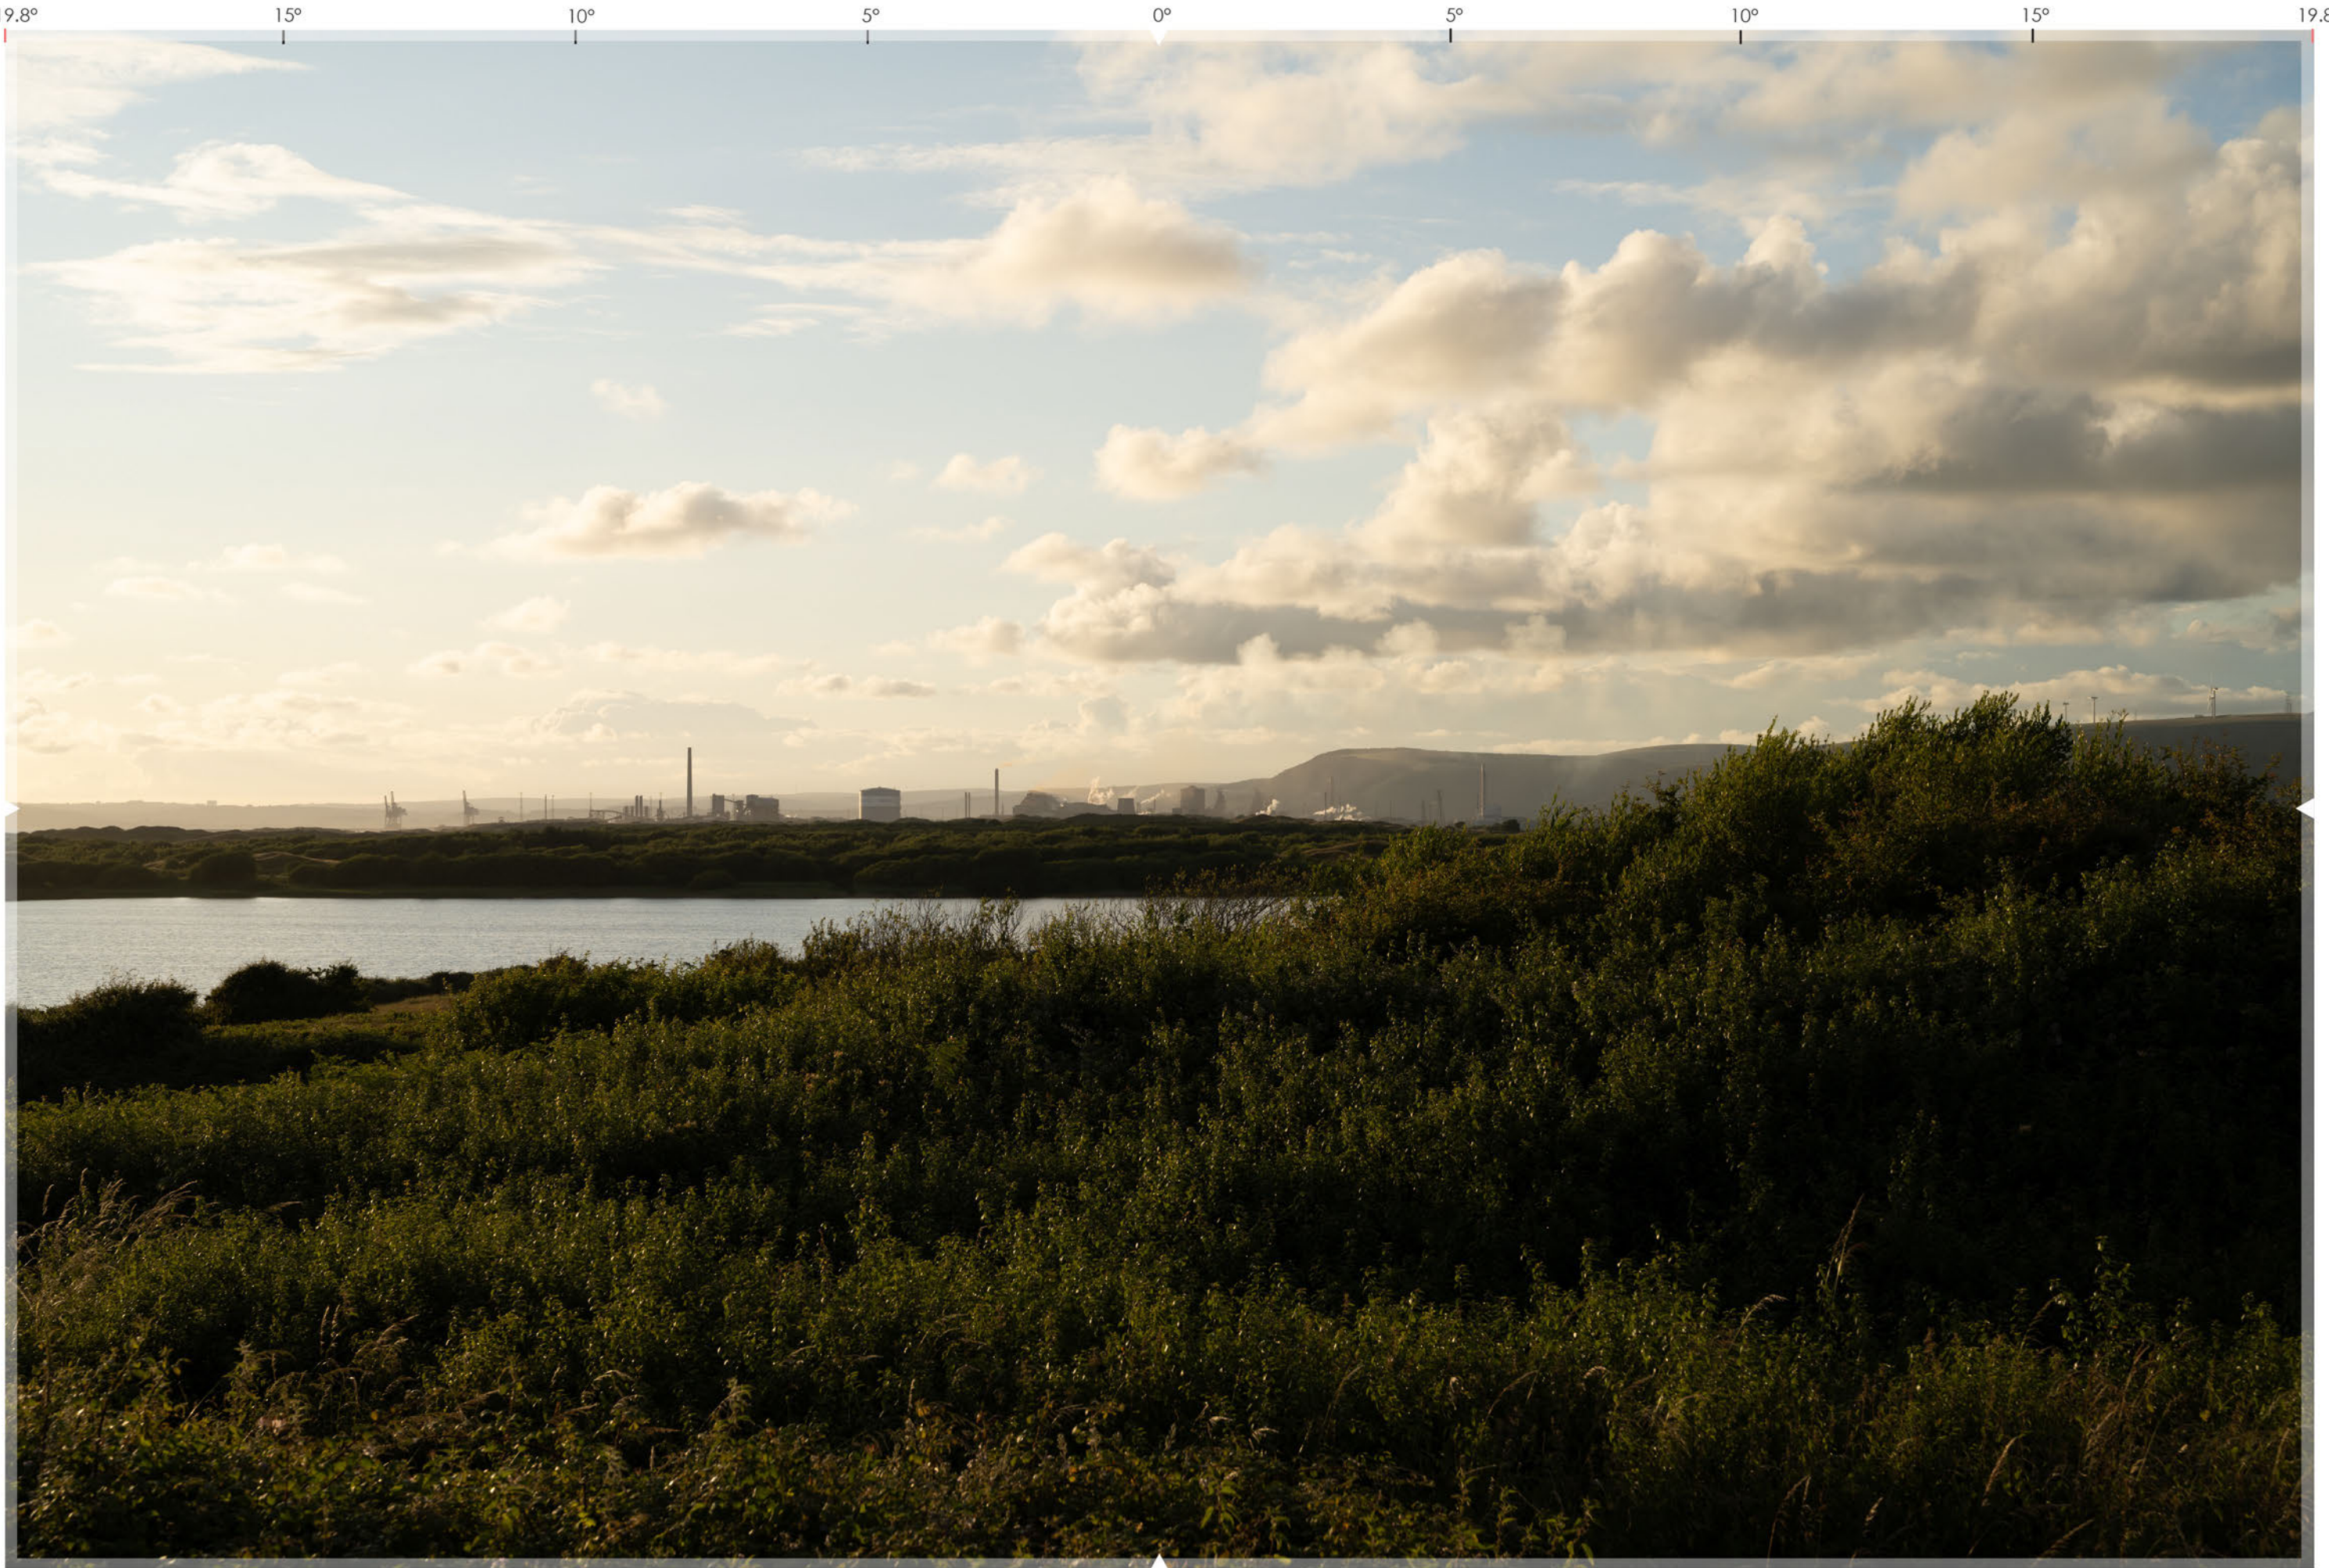
## VIEWPOINT 13, KENFIG NATURE RESERVE

279982.8673m (E), 181090.9291m (N), 24.3846m (AOD)

07 JULY 2024

Each viewpoint required 9x photographs to capture the passage of natural light from the end of day through sunset, dusk, twilight and then night-time. During the time of shooting in July, shots were taken from roughly 2015 hours through to 2330 hours.

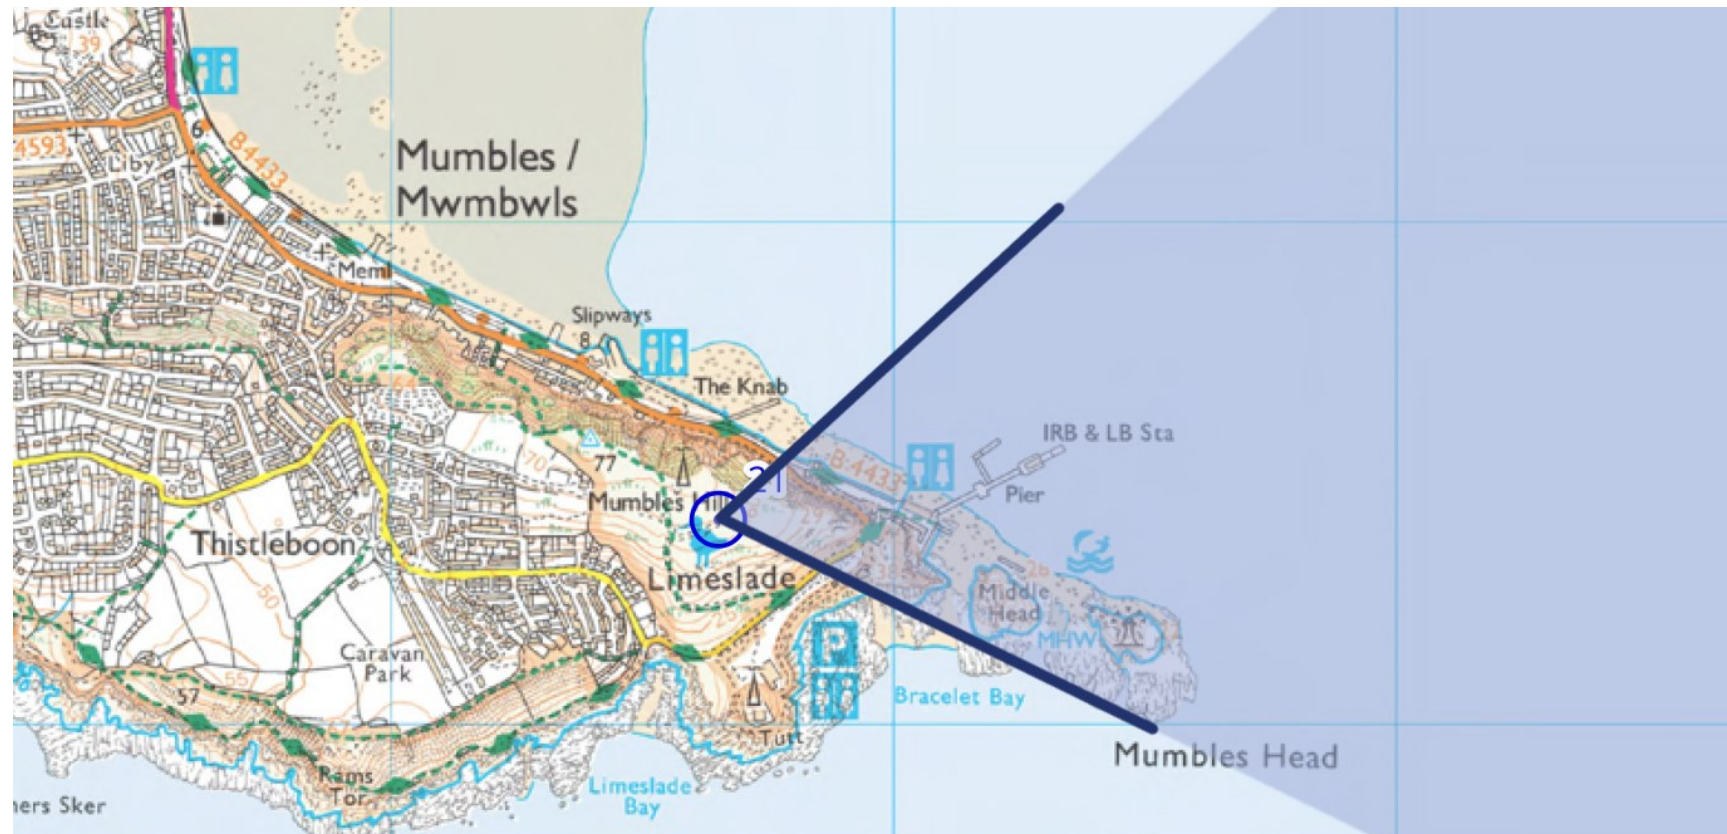
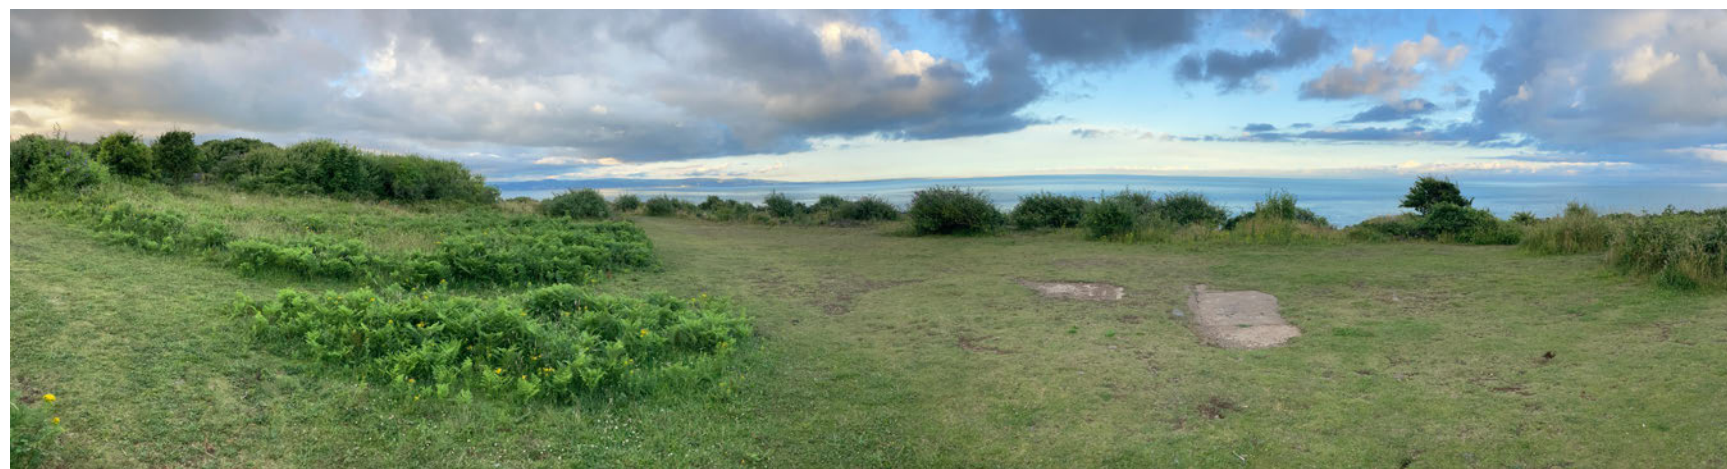
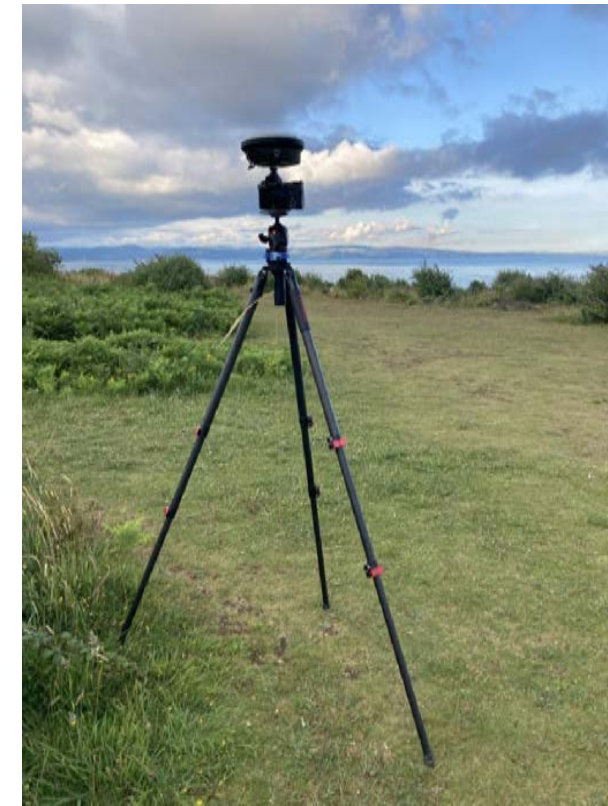
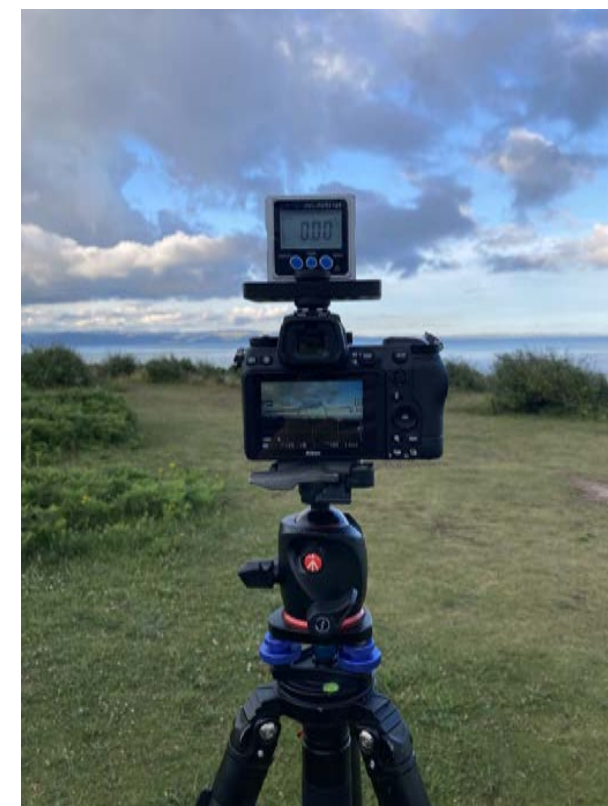
## VIEWPOINT 21, MUMBLES HILL

262649.0774m (E), 187395.3324m (N), 65.0803m (AOD)

11 JULY 2024

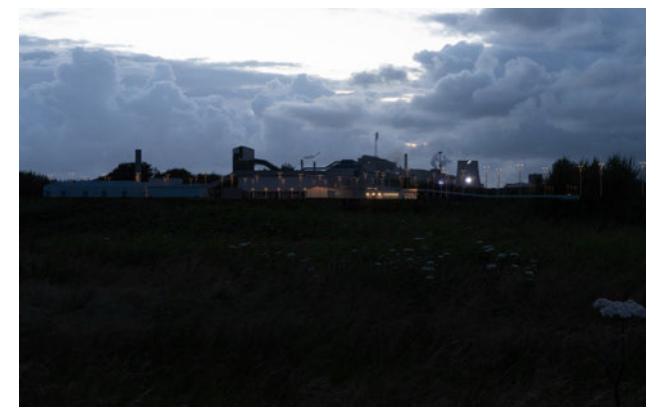
Close up of render superimposed over VP1 image without masking

Finally, the rendered images were overlaid with the viewpoint photo in Photoshop and masking was added to hide the render behind blocking foreground elements such as treelines or existing buildings.
